PROBLEM SUMMARY

Area
Flex N Gate - F00700
Machine Id
RB029
Component
Gear Unit
Fluid
GEAR OIL ISO 220 (--- GAL)

OIL ANALYSIS REPORT

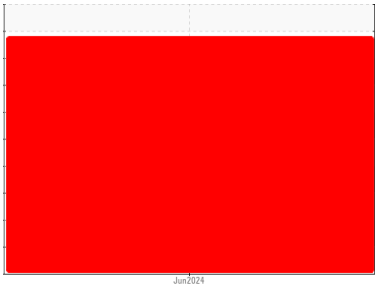
Sample Rating Trend

The sample submitted is 32 times dirtier than the ISO dirt count recommendation of 19/16/14.
Viscosity at 40 °C is out of spec (220 ± 22 cSt).

Contamination
Particles >14µm are severely high. Particles >6µm are severely high. Particles >4µm are severely high. Oil Cleanliness are severely high. Particles >21µm are abnormally high. Potassium ppm levels are notably high. Particles >38µm are notably high.

Fluid Condition
Visc @ 100°C is abnormally low. Visc @ 40°C is abnormally low. Viscosity Index (VI) is abnormally low.

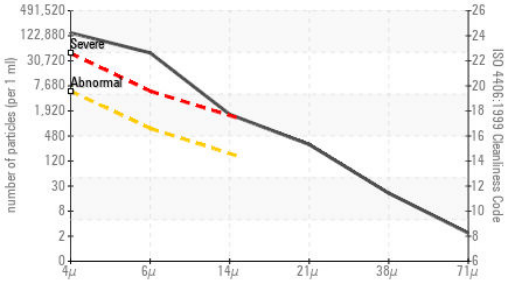
Particle Count

FLUID CLEANLINESS		method	limit/base	current	history1	history2
Particles >4µm		ASTM D7647	>5000	▲ **124316**	---	---
Particles >6µm		ASTM D7647	>640	▲ **41256**	---	---
Particles >14µm		ASTM D7647	>160	▲ **1388**	---	---
Particles >21µm		ASTM D7647	>40	▲ **263**	---	---
Particles >38µm		ASTM D7647	>10	● **18**	---	---
Particles >71µm		ASTM D7647	>3	**2**	---	---
Oil Cleanliness		ISO 4406 (c)	>19/16/14	▲ **24/23/18**	---	---

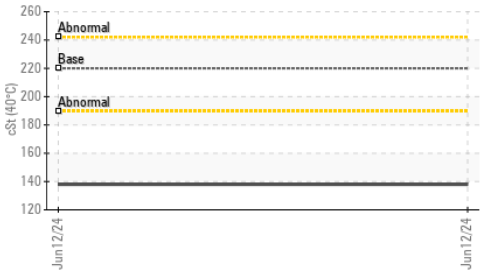
Viscosity @ 40°C

FLUID PROPERTIES		method	limit/base	current	history1	history2
Visc @ 40°C	cSt	ASTM D7279(m)	220	▲ **138**	---	---
Visc @ 100°C	cSt	ASTM D7279(m)	19.0	▲ **12.3**	---	---
Viscosity Index (VI)	Scale	ASTM D2270*	96	▲ **73**	---	---
