Area
General Recycling - 888097
Machine Id
A2406098
Component
Hydraulic System
Fluid
{not provided} (--- GAL)

OIL ANALYSIS REPORT

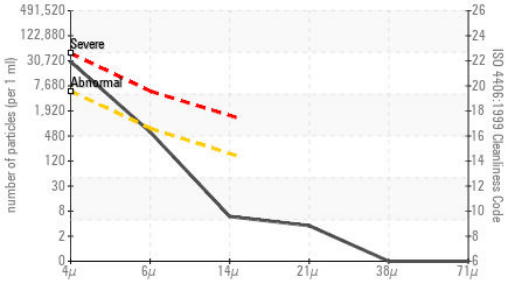
Particle Count

The sample submitted is 8 times dirtier than the ISO dirt count recommendation of 19/16/14.

Contamination
Particles >4µm and oil cleanliness are abnormally high.

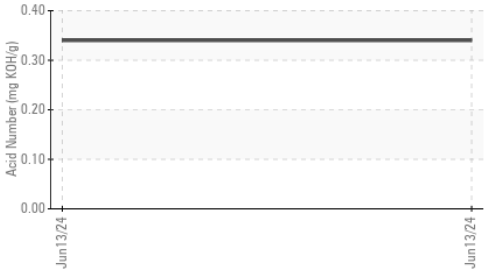
FLUID DEGRADATION		method	limit/base	current	history1	history2
Acid Number (AN)	mg KOH/g	ASTM D974*		**0.34**	---	---
