Area
Stadacona - S11900
Machine Id
PG099
Component
Unknown Component
Fluid
MOBIL DTE PM 220 (--- GAL)

Customer Id: CHECOB
Sample No.: E30002443
Lab Number: 02643492
Test Package: IND 2

OIL ANALYSIS REPORT

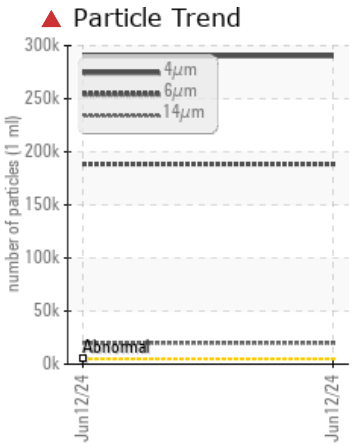
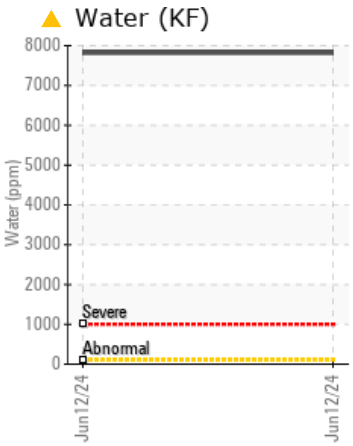
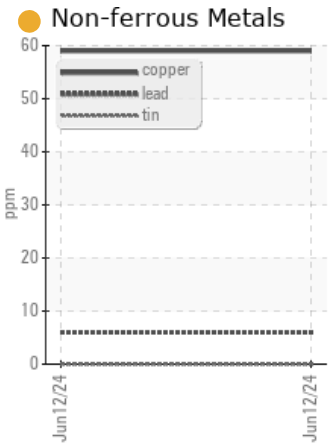
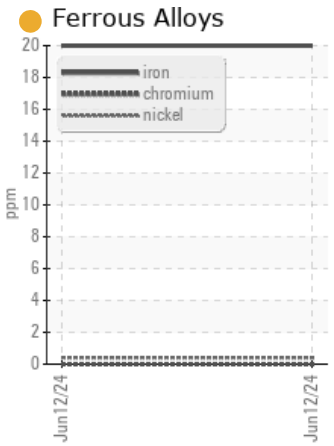
COMPONENT CONDITION SUMMARY

The sample submitted is 64 times dirtier than the ISO dirt count recommendation of 19/16/14.
The water content is higher than the recommended level of 300 ppm.
Copper and Iron ppm levels are noted.
We recommend monitoring these metals content.

Sample Status				**SEVERE**	---	---
Water	%	ASTM D6304*		▲ **0.782**	---	---
ppm Water	ppm	ASTM D6304*		▲ **7821**	---	---
Particles >4µm		ASTM D7647	>5000	▲ **290274**	---	---
Particles >6µm		ASTM D7647	>640	▲ **188474**	---	---
Particles >14µm		ASTM D7647	>160	▲ **19950**	---	---
Particles >21µm		ASTM D7647	>40	▲ **2982**	---	---
Particles >38µm		ASTM D7647	>10	▲ **23**	---	---
Oil Cleanliness		ISO 4406 (c)	>19/16/14	▲ **25/25/21**	---	---
Emulsified Water	scalar	Visual*		▲ **1%**	---	---

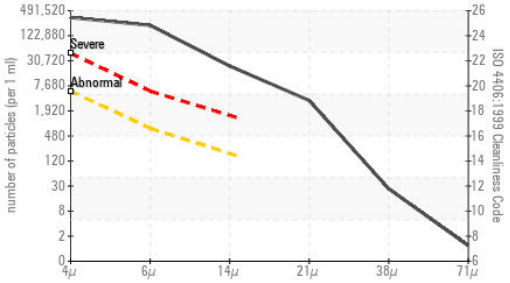
Particle Count

Contamination
Particles >14µm are severely high. Particles >21µm are severely high. Particles >6µm are severely high. Oil Cleanliness are severely high. Particles >4µm are severely high. Water contamination levels are abnormally high. Water contamination levels are abnormally high.. ppm Water contamination levels are abnormally high. Particles >38µm are abnormally high.

Recommendation
The sample submitted is 64 times dirtier than the ISO dirt count recommendation of 19/16/14.
The water content is higher than the recommended level of 300 ppm.
Copper and Iron ppm levels are noted.
We recommend monitoring these metals content.

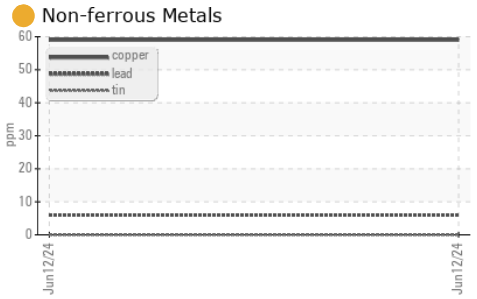
Non-ferrous Metals

Wear
Copper ppm levels are noted.
