OIL ANALYSIS REPORT

Area
[1034]
Machine Id
HATZ 1840622 002662
Component
Diesel Engine
Fluid
{not provided} (--- GAL)

SAMPLE INFORMATION		method	limit/base	current	history1	history2
Sample Number		Client Info		**WC0957977**	---	---
Sample Date		Client Info		**21 Jun 2024**	---	---
Machine Age	hrs	Client Info		**0**	---	---
Oil Age	hrs	Client Info		**0**	---	---
Oil Changed		Client Info		**N/A**	---	---
Sample Status				**SEVERE**	---	---

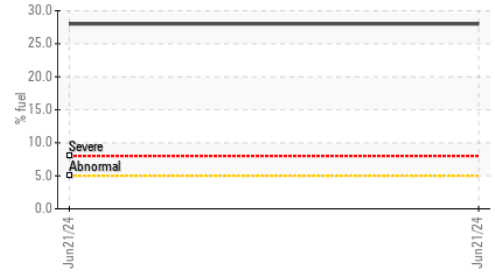
Fuel Dilution

There is a high amount of fuel present in the oil. There is a trace of moisture present in the oil. Elemental levels of silicon (Si) and aluminum (Al) indicate alumina-silicate (coarse dirt) ingress. Test for glycol is negative. Tests confirm the presence of fuel in the oil.

CONTAMINANTS		method	limit/base	current	history1	history2
Silicon	ppm	ASTM D5185(m)	>25	▲ **31**	---	---
Sodium	ppm	ASTM D5185(m)		**3**	---	---
Potassium	ppm	ASTM D5185(m)	>20	**<1**	---	---
Fuel	%	ASTM D7593*	>5	▲ **28**	---	---
Water	%	ASTM D6304*	>0.2	▲ **0.132**	---	---
ppm Water	ppm	ASTM D6304*	>2000	▲ **1328**	---	---
Glycol	%	ASTM D7922*		**0.0**	---	---

We advise that you check the fuel injection system. We advise that you check the air filter, air induction system, and any areas where dirt may enter the component. We advise that you check the air filter, air induction system, and any areas where dirt may enter the component. We recommend that you drain the oil from the component if this has not already been done. We recommend an early resample to monitor this condition. Please specify the brand, type, and viscosity of the oil on your next sample.
