PROBLEM SUMMARY

Area
BRUCE B/0B/54300
Machine Id
0B-54300-EPG2-CP1-OIL
Component
Compressor
Fluid
ESSO NUTO H ISO 150 (--- GAL)

OIL ANALYSIS REPORT

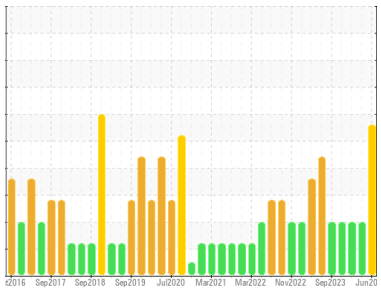
Sample Rating Trend

WATER

Sample Status				**SEVERE**	SEVERE	SEVERE
Particles >4µm		ASTM D7647	>10000	▲ **117574**	▲ 85522	▲ 103030
Particles >6µm		ASTM D7647	>2500	▲ **6466**	▲ 8584	▲ 8717
Oil Cleanliness		ISO 4406 (c)	>20/18/15	▲ **24/20/12**	▲ 24/20/12	▲ 24/20/12
White Metal	scalar	Visual*	NONE	▲ **VLITE**	NONE	NONE
Appearance	scalar	Visual*	NORML	▲ **WGOIL**	NORML	HAZY
Free Water	scalar	Visual*		▲ **1%**	NEG	NEG
PrtFilter

We advise that you check for the source of water entry. Check seals and/or filters for points of contaminant entry. The air breather requires service. If unrated, we recommend that you replace with a suitable micron rated and/or desiccant air breather. If rated, we recommend that you service/replace the breather. We advise that you use off-line filtration with water adsorbent filters to attempt to remove the water from this oil. We recommend you service the filters on this component. Resample in 30-45 days to monitor this situation. NOTE: Please provide information regarding reservoir capacity, filter type and micron rating with next sample.

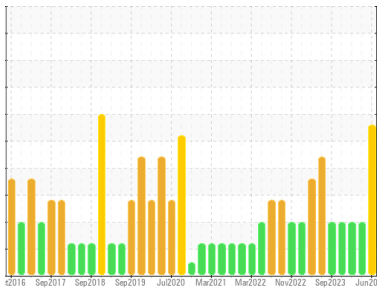
Sample Rating Trend

WATER

There is a high amount of silt (particulates < 14 microns in size) present in the oil. Free water present.

We advise that you check for the source of water entry. Check seals and/or filters for points of contaminant entry. The air breather requires service. If unrated, we recommend that you replace with a suitable micron rated and/or desiccant air breather. If rated, we recommend that you service/replace the breather. We advise that you use off-line filtration with water adsorbent filters to attempt to remove the water from this oil. We recommend you service the filters on this component. Resample in 30-45 days to monitor this situation. NOTE: Please provide information regarding reservoir capacity, filter type and micron rating with next sample.

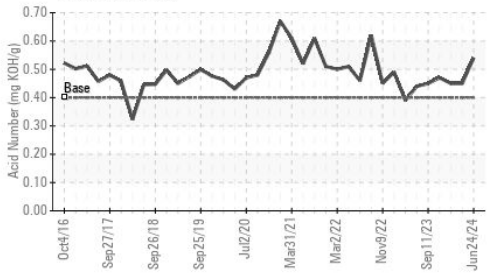
The AN level is acceptable for this fluid. The oil is still serviceable provided that the contaminant(s) can be reduced to acceptable levels.

FLUID DEGRADATION		method	limit/base	current	history1	history2
Acid Number (AN)	mg KOH/g	ASTM D974*	.40	**0.54**	0.45	0.45

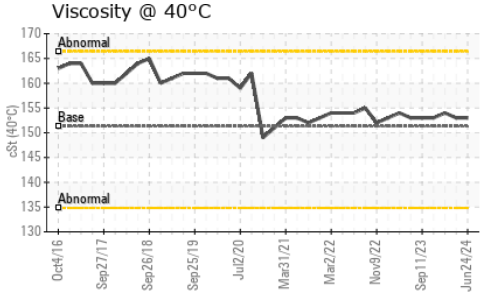
Viscosity @ 40°C

FLUID PROPERTIES		method	limit/base	current	history1	history2
Visc @ 40°C	cSt	ASTM D7279(m)	151.3	**153**	153	154

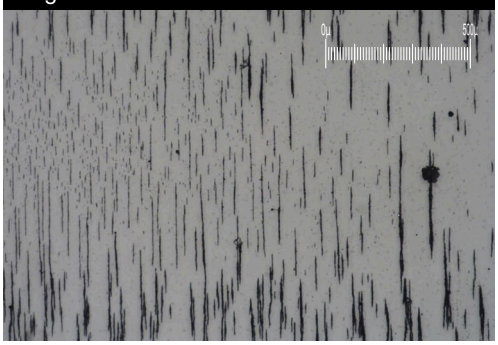
Magn: 50x Illum: RW

Light concentration of visible metal present. The ferrography results are normal indicating no abnormal wear in the system.
