OIL ANALYSIS REPORT

Area
Apel Extrusions - 888019
Machine Id
PL002-R
Component
Hydraulic System
Fluid
AW HYDRAULIC OIL ISO 46 (--- GAL)

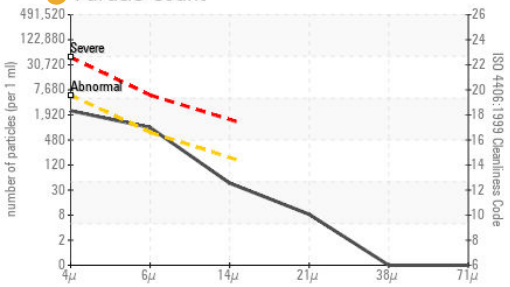
Particle Count

Recommendation
The sample submitted is 2 times dirtier than the ISO dirt count recommendation of 19/16/14.

Contamination
Particles >6µm and oil cleanliness are notably high.

FLUID CLEANLINESS		method	limit/base	current	history1	history2
Particles >4µm		ASTM D7647	>5000	**2111**	---	---
Particles >6µm		ASTM D7647	>640	**837**	---	---
Particles >14µm		ASTM D7647	>160	**39**	---	---
Particles >21µm		ASTM D7647	>40	**7**	---	---
Particles >38µm		ASTM D7647	>10	**0**	---	---
Particles >71µm		ASTM D7647	>3	**0**	---	---
Oil Cleanliness		ISO 4406 (c)	>19/16/14	**18/17/12**	---	---
