OIL ANALYSIS REPORT

Area
KDAC
Machine Id
200288
Component
Diesel Engine
Fluid
TEST OIL GOLD 4 (40 LTR)

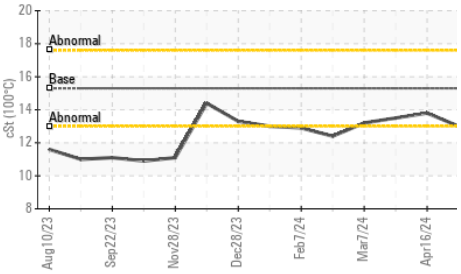
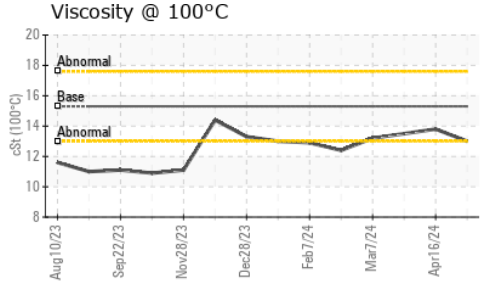
Viscosity @ 100°C

Fluid Condition
The BN result indicates that there is suitable alkalinity remaining in the oil. The condition of the oil is suitable for further service.

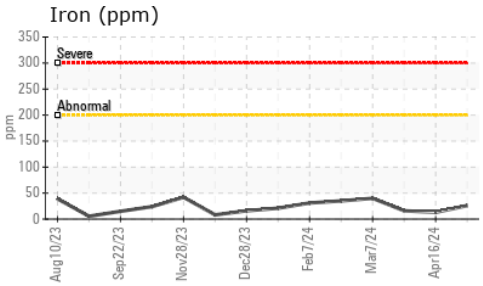
Iron (ppm)

Wear
All component wear rates are normal.

Recommendation
Resample at the next service interval to monitor.

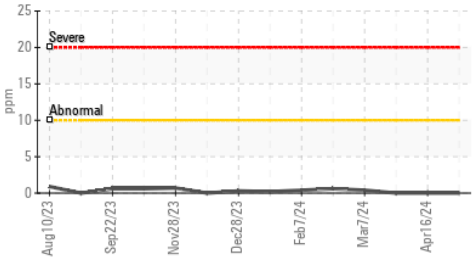
Lead (ppm)

Contamination
Elevated aluminum (Al) and/or lead (Pb) and potassium (K) levels in your metals analysis are likely a result of solder flux release into the lubricant and is common on new equipment/components. There is no indication of any contamination in the oil.
