OIL ANALYSIS REPORT

Area
KDAC
Machine Id
200250
Component
Diesel Engine
Fluid
TEST OIL GOLD 4 (40 LTR)

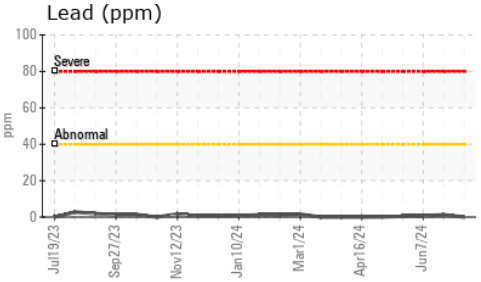
Lead (ppm)

Contamination
Elevated aluminum (Al) and/or lead (Pb) and potassium (K) levels in your metals analysis are likely a result of solder flux release into the lubricant and is common on new equipment/components. There is no indication of any contamination in the oil.

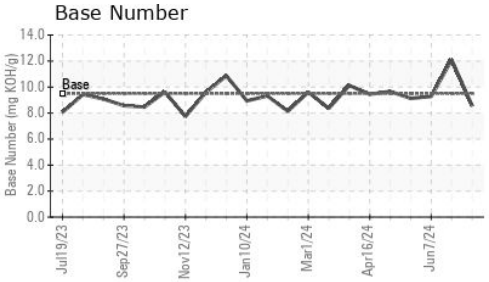
Base Number

Fluid Condition
The BN result indicates that there is suitable alkalinity remaining in the oil. The condition of the oil is suitable for further service.
