OIL ANALYSIS REPORT

Area
[97623014]
Machine Id
Wacker Neuson 97623041
Component
Front Diesel Engine
Fluid
SAE 5W40 (3 LTR)

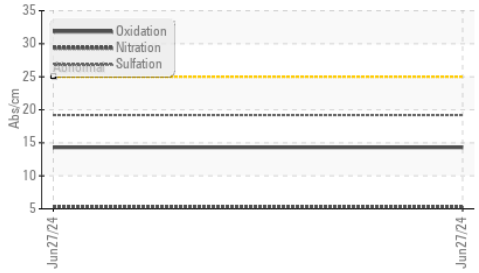
FT-IR (Direct Trend)

Contamination
Light fuel dilution occurring.

Fluid Condition
Fuel is present in the oil and is lowering the viscosity. The condition of the oil is acceptable for the time in service.

Recommendation
Resample at the next service interval to monitor. (Customer Sample Comment: oil level high)

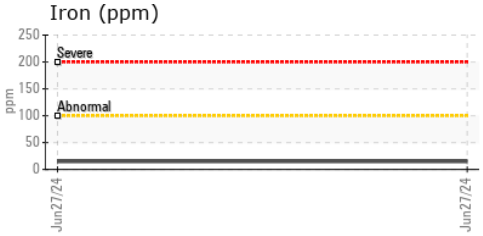
Iron (ppm)

Wear
Metal levels are typical for a components first oil change.
