Customer Id: CHECOB
Sample No.: E30002523
Lab Number: 02645462
Test Package: IND 2

OIL ANALYSIS REPORT

Area
Aalbers Tool & Mold - 888093
Machine Id
RB037
Component
Hydraulic System
Fluid
ACTIVELUBE HYD ISO 32 (--- GAL)

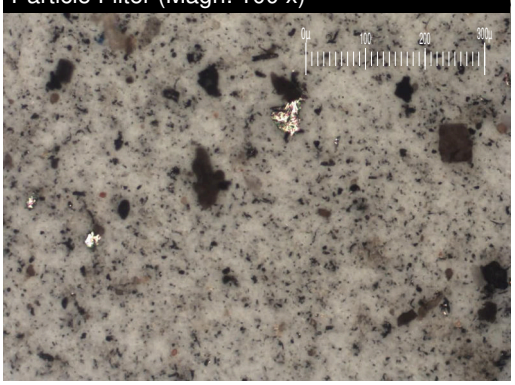
Particle Filter (Magn: 100 x)

Contamination
Particles >14µm are severely high. Particles >21µm are severely high. Particles >6µm are severely high. Oil Cleanliness are severely high. Particles >4µm are severely high. Particles >4µm are severely high.. Particles >38µm are abnormally high.

Recommendation
The sample submitted is 32 times dirtier than the ISO dirt count recommendation of 19/16/14.

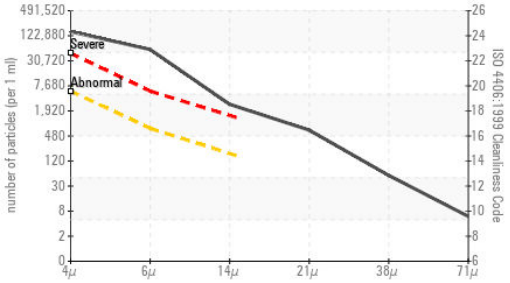
Particle Count

FLUID CLEANLINESS		method	limit/base	current	history1	history2
Particles >4µm		ASTM D7647	>5000	▲ **132952**	---	---
Particles >6µm		ASTM D7647	>640	▲ **49647**	---	---
Particles >14µm		ASTM D7647	>160	▲ **2417**	---	---
Particles >21µm		ASTM D7647	>40	▲ **583**	---	---
Particles >38µm		ASTM D7647	>10	▲ **48**	---	---
Particles >71µm		ASTM D7647	>3	**5**	---	---
Oil Cleanliness		ISO 4406 (c)	>19/16/14	▲ **24/23/18**	---	---
