Area
Aalbers Tool & Mold - 888093
Machine Id
RB040
Component
Hydraulic System
Fluid
ACTIVELUBE HYD ISO 32 (--- GAL)

Customer Id: CHECOB
Sample No.: E30002526
Lab Number: 02645477
Test Package: IND 2

OIL ANALYSIS REPORT

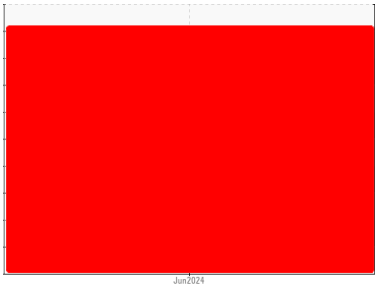
Sample Rating Trend

The sample submitted is 32 times dirtier than the ISO dirt count recommendation of 19/16/14.

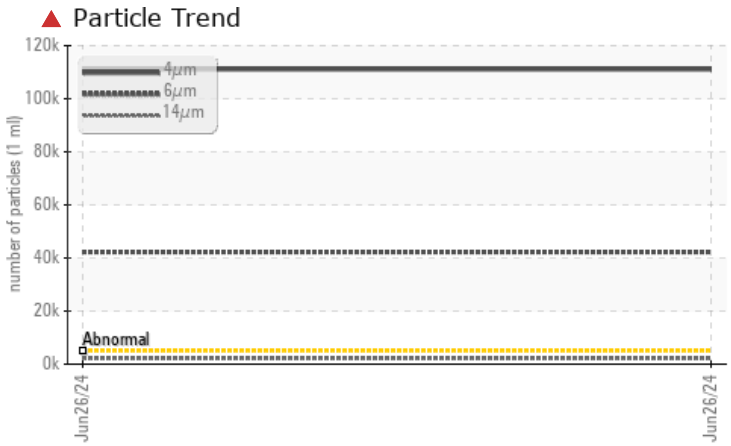
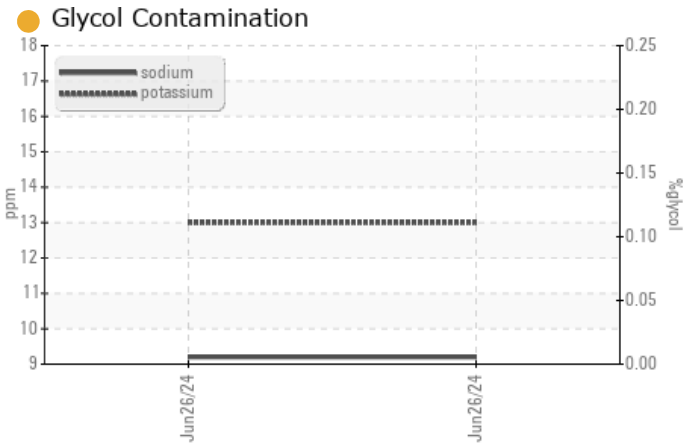
COMPONENT CONDITION SUMMARY

Sample Status				SEVERE	---	---
Particles >4µm		ASTM D7647	>5000	▲ **111115**	---	---
Particles >6µm		ASTM D7647	>640	▲ **42235**	---	---
Particles >14µm		ASTM D7647	>160	▲ **2148**	---	---
Particles >21µm		ASTM D7647	>40	▲ **443**	---	---
Particles >38µm		ASTM D7647	>10	▲ **30**	---	---
Oil Cleanliness		ISO 4406 (c)	>19/16/14	▲ **24/23/18**	---	---

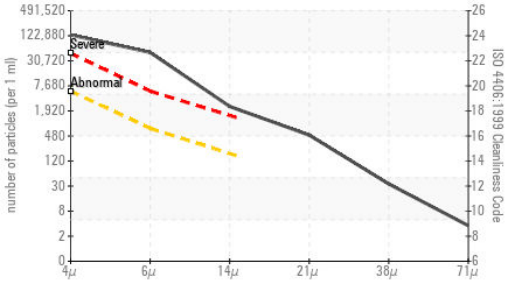
Particle Count

FLUID CLEANLINESS		method	limit/base	current	history1	history2
Particles >4µm		ASTM D7647	>5000	▲ **111115**	---	---
Particles >6µm		ASTM D7647	>640	▲ **42235**	---	---
Particles >14µm		ASTM D7647	>160	▲ **2148**	---	---
Particles >21µm		ASTM D7647	>40	▲ **443**	---	---
Particles >38µm		ASTM D7647	>10	▲ **30**	---	---
Particles >71µm		ASTM D7647	>3	**3**	---	---
Oil Cleanliness		ISO 4406 (c)	>19/16/14	▲ **24/23/18**	---	---

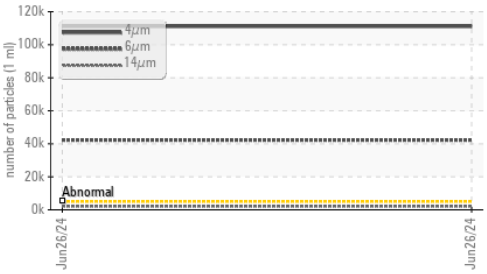
Particle Trend

Contamination
Particles >14µm are severely high. Particles >21µm are severely high. Particles >6µm are severely high. Oil Cleanliness are severely high. Particles >4µm are severely high. Particles >38µm are abnormally high. Potassium ppm levels are notably high.

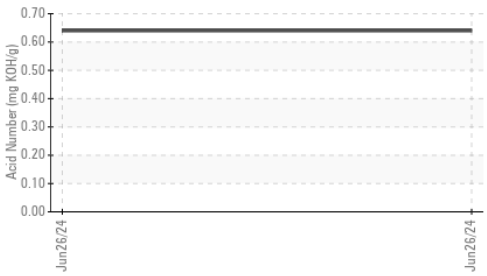
FLUID DEGRADATION		method	limit/base	current	history1	history2
Acid Number (AN)	mg KOH/g	ASTM D974*		**0.64**	---	---

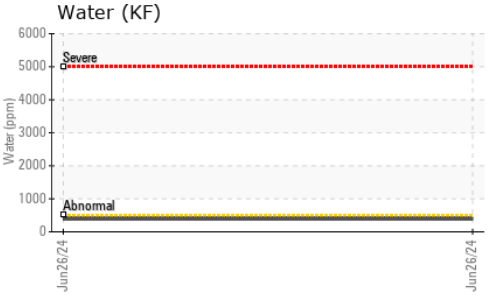
Water (KF)

CONTAMINANTS		method	limit/base	current	history1	history2
Silicon	ppm	ASTM D5185(m)	>15	0	---	---
Sodium	ppm	ASTM D5185(m)		9	---	---
Potassium	ppm	ASTM D5185(m)	>20	13	---	---
Water	%	ASTM D6304*	>0.05	0.039	---	---
ppm Water	ppm	ASTM D6304*	>500	391	---	---
