OIL ANALYSIS REPORT

Area
SAB1
Machine Id
SAB1 G4
Component
Thrust Bearing
Fluid
ESSO TERESSO ISO 46 (1182 LTR)

SAMPLE INFORMATION		method	limit/base	current	history1	history2
Sample Number		Client Info		**WC0933968**	WC0864646	WC0864636
Sample Date		Client Info		**03 Jul 2024**	15 May 2024	21 Dec 2023
Machine Age	hrs	Client Info		**0**	0	0
Oil Age	hrs	Client Info		**0**	0	0
Oil Changed		Client Info		**N/A**	N/A	N/A
Sample Status				**MARGINAL**	NORMAL	NORMAL

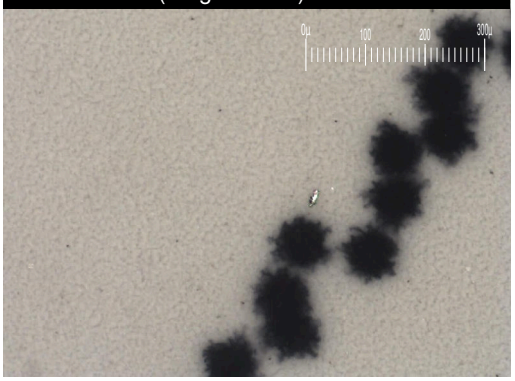
Particle Filter (Magn: 100 x)

Light concentration of visible metal present. All other component wear rates are normal.

We advise that you check for visible metal particles in the oil. We recommend an early resample to monitor this condition. Please contact your representative for information regarding the proper sampling kits for your service. NOTE: We recommend using IND 3 test kits, this testkit includes Analytical Ferrography which provides a detailed morphological analysis of wear particles present in the fluid.

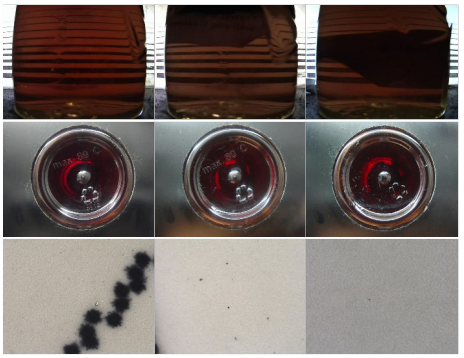
SAMPLE IMAGES	method	limit/base	current	history1	history2
Color					
Bottom					
PrtFilter

VISUAL		method	limit/base	current	history1	history2
White Metal	scalar	Visual*	NONE	▲ **VLITE**	NONE	NONE
Yellow Metal	scalar	Visual*	NONE	**NONE**	NONE	NONE
Precipitate	scalar	Visual*	NONE	**NONE**	NONE	NONE
Silt	scalar	Visual*	NONE	**NONE**	NONE	NONE
Debris	scalar	Visual*	NONE	**NONE**	NONE	NONE
Sand/Dirt	scalar	Visual*	NONE	**NONE**	NONE	NONE
Appearance	scalar	Visual*	NORML	**NORML**	NORML	NORML
Odor	scalar	Visual*	NORML	**NORML**	NORML	NORML
Emulsified Water	scalar	Visual*	>2	**NEG**	NEG	NEG
Free Water	scalar	Visual*		**NEG**	NEG	NEG
