Area
Extrudex Alum - E00400
Machine Id
A2407031
Component
Hydraulic System
Fluid
AW HYDRAULIC OIL ISO 68 (--- GAL)

Customer Id: CHECOB
Sample No.: E30002582
Lab Number: 02646210
Test Package: IND 2

OIL ANALYSIS REPORT

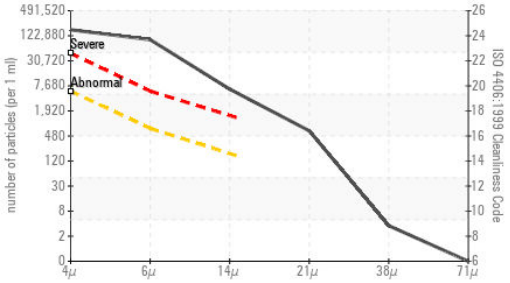
Particle Count

Contamination
Particles >14µm are severely high. Particles >21µm are severely high. Particles >6µm are severely high. Oil Cleanliness are severely high. Particles >4µm are severely high. Water and ppm water contamination levels are abnormal.

FLUID CLEANLINESS		method	limit/base	current	history1	history2
Particles >4µm		ASTM D7647	>5000	▲ **147390**	---	---
Particles >6µm		ASTM D7647	>640	▲ **85409**	---	---
Particles >14µm		ASTM D7647	>160	▲ **5589**	---	---
Particles >21µm		ASTM D7647	>40	▲ **561**	---	---
Particles >38µm		ASTM D7647	>10	**3**	---	---
Particles >71µm		ASTM D7647	>3	**0**	---	---
Oil Cleanliness		ISO 4406 (c)	>19/16/14	▲ **24/24/20**	---	---

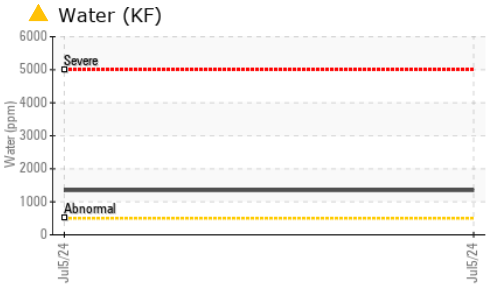
Water (KF)

CONTAMINANTS		method	limit/base	current	history1	history2
Silicon	ppm	ASTM D5185(m)	>15	**3**	---	---
Sodium	ppm	ASTM D5185(m)		**2**	---	---
Potassium	ppm	ASTM D5185(m)	>20	**1**	---	---
Water	%	ASTM D6304*	>0.05	▲ **0.134**	---	---
ppm Water	ppm	ASTM D6304*	>500	▲ **1348**	---	---

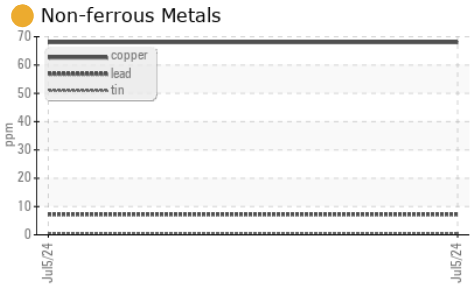
Non-ferrous Metals

Wear
Copper and iron ppm levels are noted.
