PROBLEM SUMMARY

Area
5 Utilities/030 Boiler House/B Blower/Fan/713A #13 FD West
Machine Id
N/A 30TB713A
Component
Turbine
Fluid
PETRO CANADA TURBOFLO 68 (20 LTR)

OIL ANALYSIS REPORT

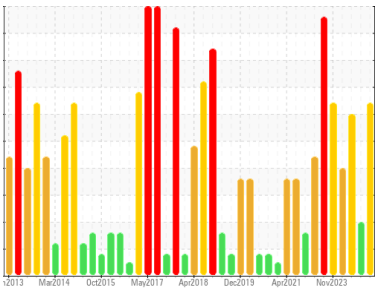
Sample Rating Trend

Sample Status				**SEVERE**	SEVERE	SEVERE
Particles >4µm		ASTM D7647	>2500	▲ **36599**	▲ 36044	▲ 114427
Particles >6µm		ASTM D7647	>640	▲ **8884**	▲ 3260	▲ 36630
Particles >14µm		ASTM D7647	>80	▲ **558**	17	▲ 623
Particles >21µm		ASTM D7647	>20	▲ **186**	3	▲ 75
Particles >38µm		ASTM D7647	>4	▲ **27**	1	3
Oil Cleanliness		ISO 4406 (c)	>18/16/13	▲ **22/20/16**	▲ 22/19/11	▲ 24/22/16

We advise that you check all areas where contaminants can enter the system. We advise that you perform a filter service, and use off-line filtration to improve the cleanliness of the system fluid. The air breather requires service. If unrated, we recommend that you replace with a suitable micron rated and/or desiccant air breather. If rated, we recommend that you service/replace the breather. Resample in 30-45 days to monitor this situation.

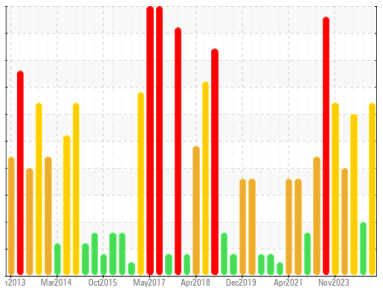
Sample Rating Trend

Contamination
There is a high amount of particulates (2 to 100 microns in size) present in the oil. The water content is negligible.

FLUID CLEANLINESS		method	limit/base	current	history1	history2
Particles >4µm		ASTM D7647	>2500	▲ **36599**	▲ 36044	▲ 114427
Particles >6µm		ASTM D7647	>640	▲ **8884**	▲ 3260	▲ 36630
Particles >14µm		ASTM D7647	>80	▲ **558**	17	▲ 623
Particles >21µm		ASTM D7647	>20	▲ **186**	3	▲ 75
Particles >38µm		ASTM D7647	>4	▲ **27**	1	3
Particles >71µm		ASTM D7647	>3	**2**	1	1
Oil Cleanliness		ISO 4406 (c)	>18/16/13	▲ **22/20/16**	▲ 22/19/11	▲ 24/22/16

Recommendation
We advise that you check all areas where contaminants can enter the system. We advise that you perform a filter service, and use off-line filtration to improve the cleanliness of the system fluid. The air breather requires service. If unrated, we recommend that you replace with a suitable micron rated and/or desiccant air breather. If rated, we recommend that you service/replace the breather. Resample in 30-45 days to monitor this situation.

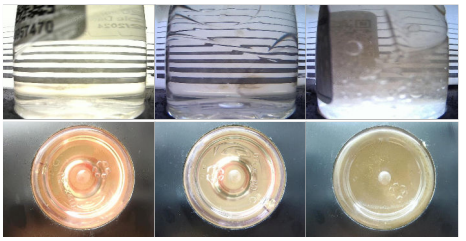
SAMPLE IMAGES	method	limit/base	current	history1	history2
Color					
Bottom

VISUAL		method	limit/base	current	history1	history2
White Metal	scalar	Visual*	NONE	**NONE**	NONE	NONE
Yellow Metal	scalar	Visual*	NONE	**NONE**	NONE	NONE
Precipitate	scalar	Visual*	NONE	**NONE**	NONE	VLITE
Silt	scalar	Visual*	NONE	**NONE**	NONE	VLITE
Debris	scalar	Visual*	NONE	**NONE**	NONE	NONE
Sand/Dirt	scalar	Visual*	NONE	**VLITE**	VLITE	VLITE
Appearance	scalar	Visual*	NORML	**NORML**	NORML	NORML
Odor	scalar	Visual*	NORML	**NORML**	NORML	NORML
Emulsified Water	scalar	Visual*	>0.03	**NEG**	NEG	.5%
Free Water	scalar	Visual*		**NEG**	NEG	▲ 5%
