Area
Flex N Gate - F00700
Machine Id
RB060
Component
Unknown Component
Fluid
EP 220 GEAR OIL (--- GAL)

Customer Id: CHECOB
Sample No.: E30002607
Lab Number: 02647497
Test Package: IND 2

OIL ANALYSIS REPORT

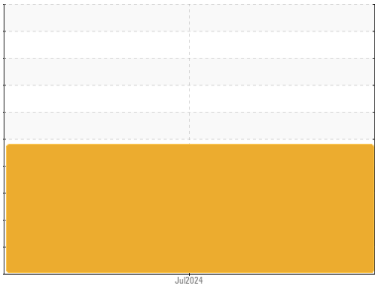
Sample Rating Trend

The sample submitted is 8 times dirtier than the ISO dirt count recommendation of 19/16/14.

Sample Status				**SEVERE**	---	---
Particles >4µm		ASTM D7647	>5000	▲ **26820**	---	---
Particles >6µm		ASTM D7647	>640	▲ **7922**	---	---
Particles >14µm		ASTM D7647	>160	▲ **428**	---	---
Particles >21µm		ASTM D7647	>40	▲ **103**	---	---
Oil Cleanliness		ISO 4406 (c)	>19/16/14	▲ **22/20/16**	---	---
Visc @ 40°C	cSt	ASTM D7279(m)		▲ **169**	---	---
Visc @ 100°C	cSt	ASTM D7279(m)		▲ **13.4**	---	---

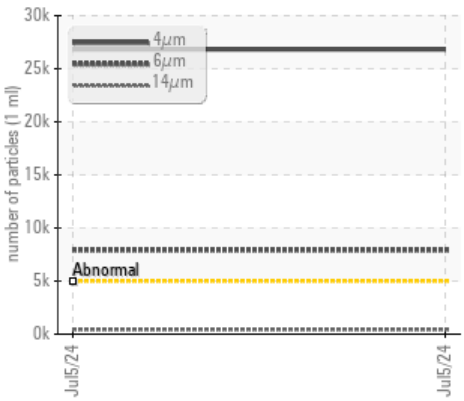
Particle Trend

Contamination
Particles >6µm are severely high. Oil Cleanliness are severely high. Particles >14µm are abnormally high. Particles >21µm are abnormally high. Particles >4µm are abnormally high.

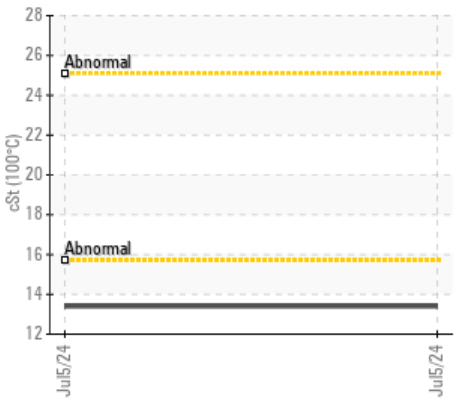
Viscosity @ 100°C

Fluid Condition
Visc @ 100°C is abnormally low. Visc @ 40°C is abnormally low.

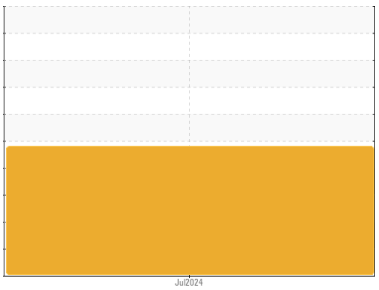
Sample Rating Trend

Recommendation
The sample submitted is 8 times dirtier than the ISO dirt count recommendation of 19/16/14.

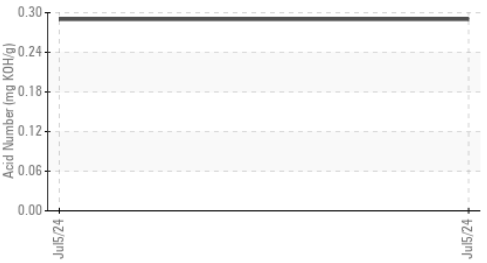
FLUID DEGRADATION		method	limit/base	current	history1	history2
Acid Number (AN)	mg KOH/g	ASTM D974*		**0.29**	---	---
