OIL ANALYSIS REPORT

Area
Power Generation
Machine Id
V837270 STANDBY POWER GENERATION 4160B PACKAGE
Component
Lube System
Fluid
MOBIL DTE OIL MEDIUM (113 LTR)

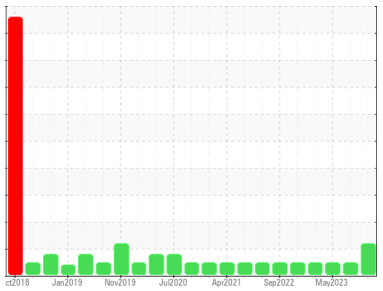
Sample Rating Trend

VISUAL METAL

Wear
Light concentration of visible metal present.

Contamination
The system cleanliness is acceptable for your target ISO 4406 cleanliness code. The system and fluid cleanliness is acceptable. NOTE: An increase in the particle count is noted.

Recommendation
We advise that you check for visible metal particles in the oil. We recommend an early resample to monitor this condition.
