OIL ANALYSIS REPORT

Area
Firewater
Machine Id
V411201D FWP PACKAGE D
Component
Hydraulic System
Fluid
MOBIL DTE 10 EXCEL 32 (--- LTR)

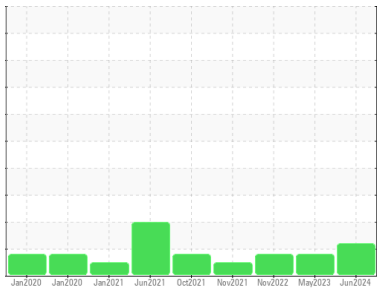
Sample Rating Trend

Contamination
There is a moderate amount of silt (particulates < 14 microns in size) present in the oil.

FLUID CLEANLINESS		method	limit/base	current	history1	history2
Particles >4µm		ASTM D7647	>5000	▲ **23596**	▲ 10503	● 5055
Particles >6µm		ASTM D7647	>1300	● **1879**	925	690
Particles >14µm		ASTM D7647	>160	**33**	15	51
Particles >21µm		ASTM D7647	>40	**10**	3	15
Particles >38µm		ASTM D7647	>10	**2**	0	2
Particles >71µm		ASTM D7647	>3	**1**	0	1
Oil Cleanliness		ISO 4406 (c)	>19/17/14	▲ **22/18/12**	▲ 21/17/11	● 20/17/13

Recommendation
We recommend you service the filters on this component. We recommend an early resample to monitor this condition. NOTE: Please provide information regarding reservoir capacity, filter type and micron rating with next sample.
