OIL ANALYSIS REPORT

Area
(411) A22
Machine Id
GENERATOR FIREWATER PUMP A
Component
Bearing
Fluid
MOBIL DTE OIL MEDIUM (113 LTR)

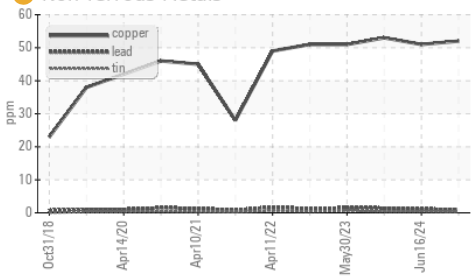
Non-ferrous Metals

Wear
Copper ppm levels are noted. All other component wear rates are normal.

Recommendation
Resample at the next service interval to monitor.

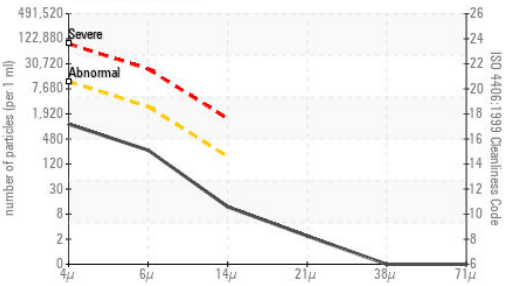
Particle Count

Contamination
The system cleanliness is acceptable for your target ISO 4406 cleanliness code. The system and fluid cleanliness is acceptable.

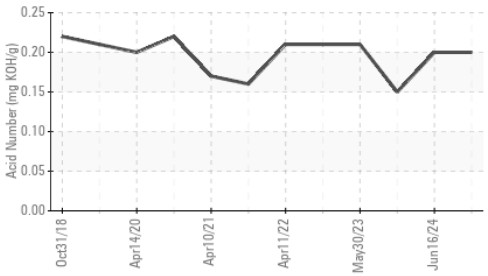
Acid Number

Fluid Condition
The AN level is acceptable for this fluid. The condition of the oil is suitable for further service.
