PROBLEM SUMMARY

Area
(C-GSUR)
Machine Id
[C-GSUR] DEHAVILLAND DASH8-102 PCE-120217
Component
Right Jet Turbine
Fluid
EASTMAN TURBO OIL 2380 (21 LTR)

FERROGRAPHY REPORT

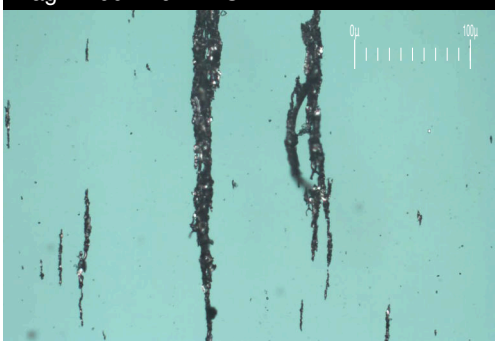
Magn: 200x Illum: BC

Wear particle analysis indicates that the ferrous cutting particles are severe. Wear particle analysis indicates that the ferrous sliding particles are abnormal. Cutting wear particles are caused by either hard protuberances (mis-aligned components, etc.), or abrasives entering the system and embedding themselves in softer materials (sand, etc.), and gouging out mating surfaces.

Recommendation
We recommend that you drain the oil from the component if this has not already been done. We recommend an early resample to monitor this condition.
