OIL ANALYSIS REPORT

Machine Id
Press #3 6561231
Component
Hydraulic System
Fluid
SHELL TELLUS S2 M 46 (251 GAL)

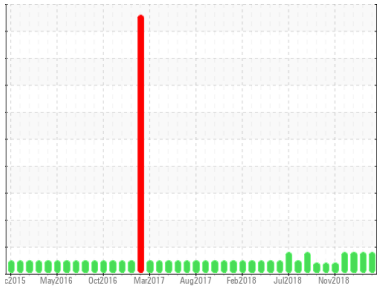
Sample Rating Trend

INSOLUBLES

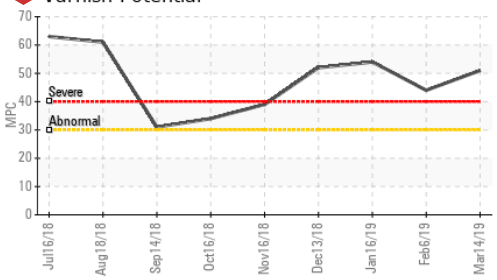
MPC (Membrane Patch Colorimetry) test indicates a high concentration of varnish present. The system cleanliness is acceptable for your target ISO 4406 cleanliness code.

FLUID DEGRADATION		method	limit/base	current	history1	history2
Acid Number (AN)	mg KOH/g	ASTM D8045		**0.382**	0.329	0.318
MPC Varnish Potential	Scale	ASTM D7843	>15	**51**	44	54

We recommend that you use electrostatic filtration to remove insolubles from the oil and to reduce the levels of varnish in the system. Alternatively draining a percentage of the oil and topping up with fresh oil (sweetening the oil) may provide a reduction in the varnish potential level. We recommend an early resample to monitor this condition.

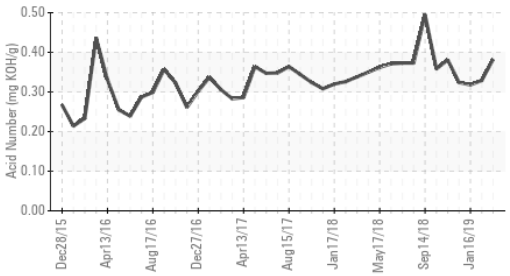
Acid Number

The AN level is acceptable for this fluid.
