Area
P1
Machine Id
3210 P-1 Centrifuge
Component
Hydraulic System
Fluid
MOBIL DTE 25 (20 GAL)

Customer Id: AJIRAL
Sample No.: WC0425045
Lab Number: 04920863
Test Package: IND 2

OIL ANALYSIS REPORT

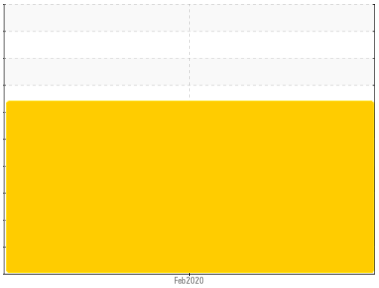
Sample Rating Trend

Sample Status				**SEVERE**	---	---
Particles >4µm		ASTM D7647	>5000	**23287**	---	---
Particles >6µm		ASTM D7647	>1300	**11326**	---	---
Particles >14µm		ASTM D7647	>160	**1598**	---	---
Particles >21µm		ASTM D7647	>40	**531**	---	---
Oil Cleanliness		ISO 4406 (c)	>19/17/14	**22/21/18**	---	---

Contamination
There is a high amount of particulates present in the oil.

The filter change at the time of sampling has been noted. Resample at the next service interval to monitor. (Customer Sample Comment: Filter on hydraulic motor sump reached high d/p alarm. Changed the filter for the first time in over 5 years, fluid is less than a year old)

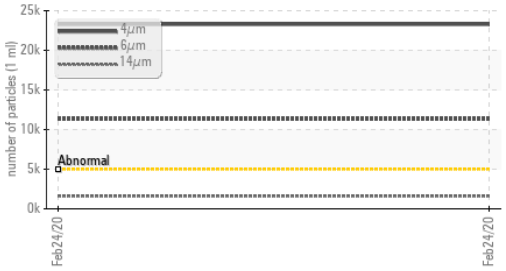
Particle Trend

FLUID CLEANLINESS		method	limit/base	current	history1	history2
Particles >4µm		ASTM D7647	>5000	▲ **23287**	---	---
Particles >6µm		ASTM D7647	>1300	**11326**	---	---
Particles >14µm		ASTM D7647	>160	**1598**	---	---
Particles >21µm		ASTM D7647	>40	**531**	---	---
Particles >38µm		ASTM D7647	>10	**13**	---	---
Particles >71µm		ASTM D7647	>3	**1**	---	---
Oil Cleanliness		ISO 4406 (c)	>19/17/14	**22/21/18**	---	---

Recommendation
The filter change at the time of sampling has been noted. Resample at the next service interval to monitor. (Customer Sample Comment: Filter on hydraulic motor sump reached high d/p alarm. Changed the filter for the first time in over 5 years, fluid is less than a year old)
