PROBLEM SUMMARY

Machine Id
T-29
Component
Wind Turbine Gearbox
Fluid
MITSUBISHI Daphne Alpha Winforce (--- GAL)

OIL ANALYSIS REPORT

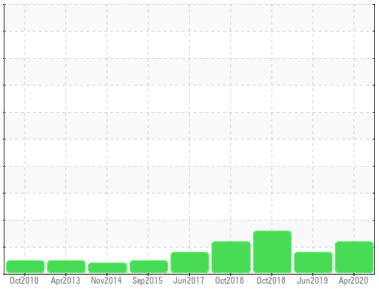
Sample Rating Trend

Sample Status				ABNORMAL	ABNORMAL	ABNORMAL
Particles >6µm		ASTM D7647	>5000	▲ **16486**	▲ 9029	▲ 23560
Particles >14µm		ASTM D7647	>640	▲ **724**	▲ 649	▲ 1219
Particles >21µm		ASTM D7647	>160	▲ **180**	147	▲ 257
Oil Cleanliness		ISO 4406 (c)	>--/19/16	▲ **23/21/17**	▲ 23/20/17	▲ 24/22/17

Replace filter element and resample at later date. In case already attempted and cleanliness was not improved then proceed to replace oil.

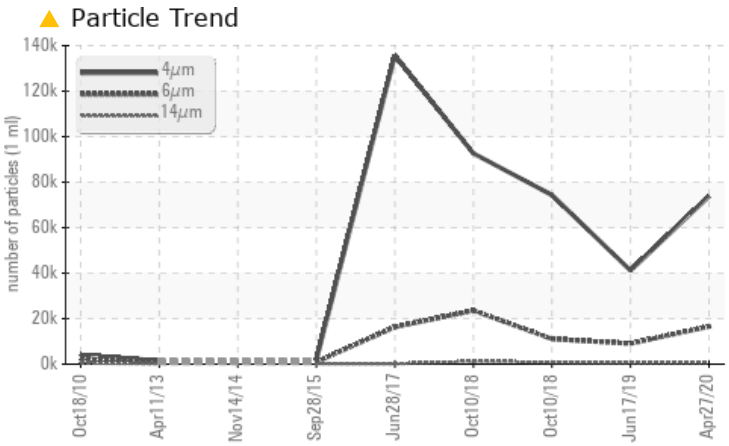
COMPONENT CONDITION SUMMARY

Contamination
There is a high amount of particulates present in the oil.

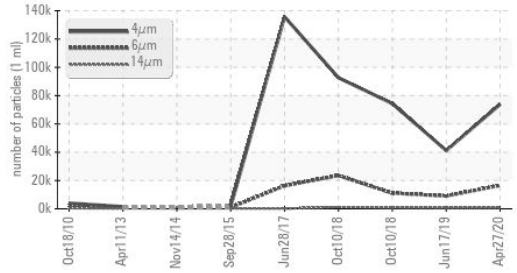
Particle Trend

FLUID CLEANLINESS		method	limit/base	current	history1	history2
Particles >4µm		ASTM D7647		**73834**	41150	92627
Particles >6µm		ASTM D7647	>5000	▲ **16486**	▲ 9029	▲ 23560
Particles >14µm		ASTM D7647	>640	▲ **724**	▲ 649	▲ 1219
Particles >21µm		ASTM D7647	>160	▲ **180**	147	▲ 257
Particles >38µm		ASTM D7647	>40	**6**	5	8
Particles >71µm		ASTM D7647	>10	**0**	0	1
Oil Cleanliness		ISO 4406 (c)	>--/19/16	▲ **23/21/17**	▲ 23/20/17	▲ 24/22/17

Recommendation
Replace filter element and resample at later date. In case already attempted and cleanliness was not improved then proceed to replace oil.
