PROBLEM SUMMARY

Machine Id
T-56
Component
Wind Turbine Gearbox
Fluid
MITSUBISHI Daphne Alpha Winforce (70 GAL)

OIL ANALYSIS REPORT

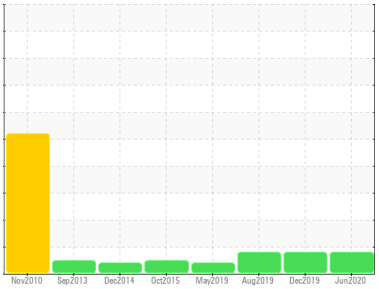
Sample Rating Trend

Sample Status				**ABNORMAL**	ABNORMAL	ABNORMAL
Particles >6µm		ASTM D7647	>5000	▲ **126447**	▲ 118081	▲ 92005
Particles >14µm		ASTM D7647	>640	▲ **1859**	▲ 677	▲ 1438
Oil Cleanliness		ISO 4406 (c)	>--/19/16	▲ **25/24/18**	▲ 26/24/17	▲ 25/24/18

Re-sample to verify the actual oil condition. Replace filter elements. Change oil if cleanliness level does not improve after replacing the filter(s).

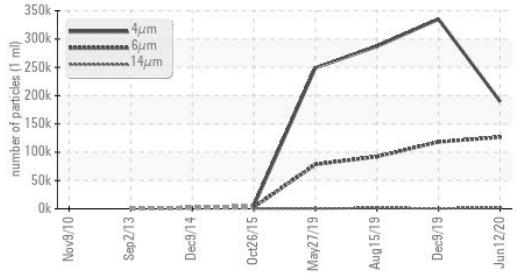
Particle Trend

Contamination
There is a high amount of particulates present in the oil.

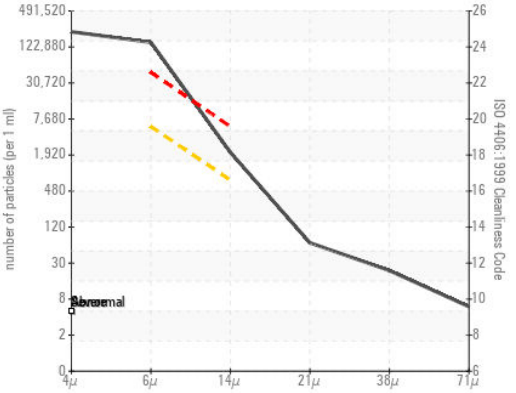
Particle Count

FLUID CLEANLINESS		method	limit/base	current	history1	history2
Particles >4µm		ASTM D7647		**189752**	335008	287067
Particles >6µm		ASTM D7647	>5000	▲ **126447**	▲ 118081	▲ 92005
Particles >14µm		ASTM D7647	>640	▲ **1859**	▲ 677	▲ 1438
Particles >21µm		ASTM D7647	>160	**58**	67	160
Particles >38µm		ASTM D7647	>40	**20**	2	4
Particles >71µm		ASTM D7647	>10	**5**	0	0
Oil Cleanliness		ISO 4406 (c)	>--/19/16	▲ **25/24/18**	▲ 26/24/17	▲ 25/24/18
