PROBLEM SUMMARY

Area
UTL
Machine Id
A65G141 LIMESTONE BULK
Component
Hydraulic System
Fluid
PETRO CANADA HYDREX AW 46 (2500 GAL)

OIL ANALYSIS REPORT

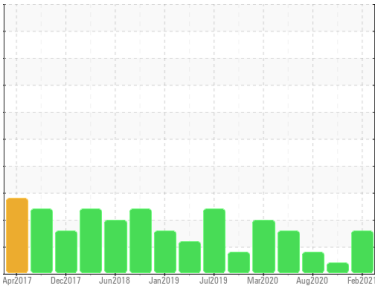
Sample Rating Trend

Sample Status				ABNORMAL	ABNORMAL	ABNORMAL
Particles >4µm		ASTM D7647	>5000	▲ **57275**	---	▲ 11969
Particles >6µm		ASTM D7647	>1300	▲ **12333**	---	▲ 1628
Particles >14µm		ASTM D7647	>160	▲ **415**	---	82
Particles >21µm		ASTM D7647	>40	▲ **87**	---	22
Oil Cleanliness		ISO 4406 (c)	>19/17/14	▲ **23/21/16**	---	▲ 21/18/14

We recommend you service the filters on this component. Resample at the next service interval to monitor.

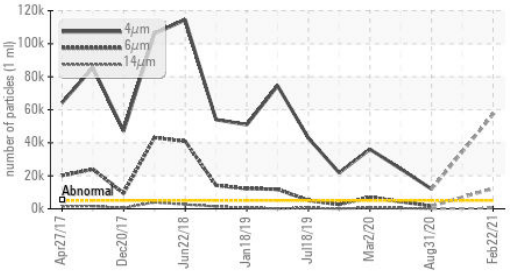
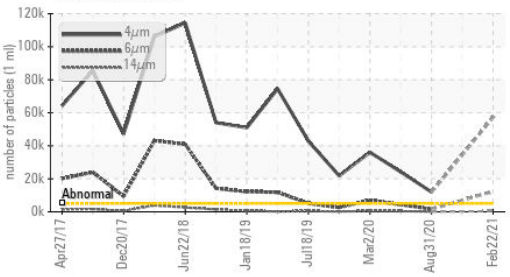
Particle Trend

Contamination
There is a high amount of particulates present in the oil.

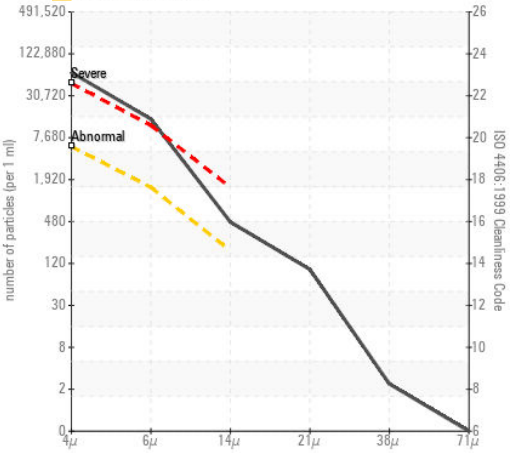
Particle Count

FLUID CLEANLINESS		method	limit/base	current	history1	history2
Particles >4µm		ASTM D7647	>5000	▲ **57275**	---	▲ 11969
Particles >6µm		ASTM D7647	>1300	▲ **12333**	---	▲ 1628
Particles >14µm		ASTM D7647	>160	▲ **415**	---	82
Particles >21µm		ASTM D7647	>40	▲ **87**	---	22
Particles >38µm		ASTM D7647	>10	**2**	---	3
Particles >71µm		ASTM D7647	>3	**0**	---	0
Oil Cleanliness		ISO 4406 (c)	>19/17/14	▲ **23/21/16**	---	▲ 21/18/14

Recommendation
We recommend you service the filters on this component. Resample at the next service interval to monitor.
