OIL ANALYSIS REPORT

Machine Id
CCUP STG
Component
Turbine
Fluid
PHILLIPS 66 TURBINE OIL ISO 32 (300 GAL)

Laboratory : WearCheck USA - 501 Madison Ave., Cary, NC 27513
Sample No. : WC0545580
Lab Number : 05204217
Unique Number : 9405626
Test Package : AOM 1 (Additional Tests: KF, RPVOT)

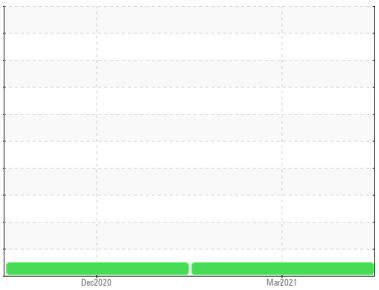
Sample Rating Trend

NORMAL

Recommendation
Resample at the next service interval to monitor.

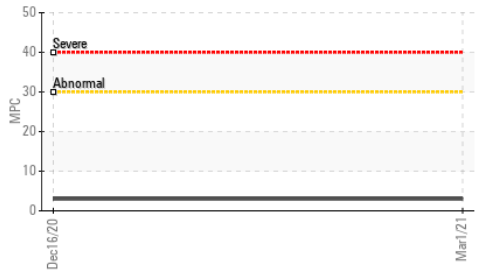
Varnish Potential

Contamination
MPC (Membrane Patch Colorimetry) test indicates acceptable levels of varnish present. The amount and size of particulates present in the system are acceptable. There is no indication of any contamination in the oil.

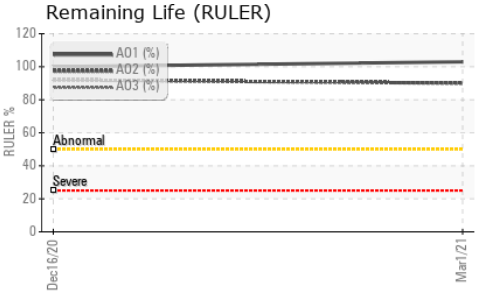
Remaining Life (RULER)

Fluid Condition
RPVOT measured at 826. The AN level is acceptable for this fluid. Linear Sweep Voltammetry (RULER – ASTM D6971) testing indicates normal levels of anti-oxidants present in the oil. The condition of the oil is suitable for further service.
