OIL ANALYSIS REPORT

Machine Id
Press #3 6561231
Component
Hydraulic System
Fluid
KLUBER KLUBEROIL 4 UH1-46 N (251 GAL)

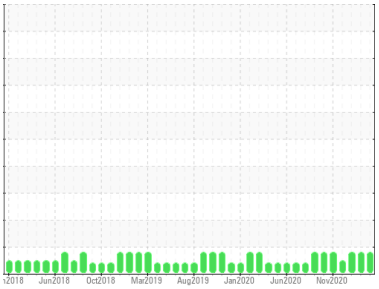
Sample Rating Trend

SAMPLE INFORMATION		method	limit/base	current	history1	history2
Sample Number		Client Info		**PTK0002094**	PTK0001983	PTK0001657
Sample Date		Client Info		**18 Mar 2021**	11 Feb 2021	18 Jan 2021
Machine Age	hrs	Client Info		**42337**	41974	41562
Oil Age	hrs	Client Info		**0**	0	510
Oil Changed		Client Info		**Not Changd**	N/A	N/A
Sample Status				**SEVERE**	SEVERE	SEVERE

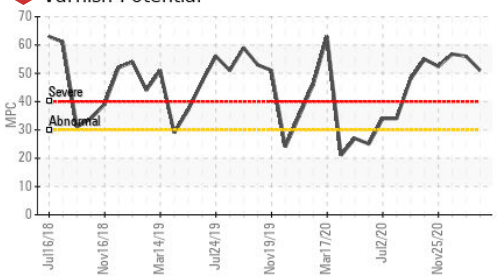
MPC (Membrane Patch Colorimetry) test indicates a high concentration of varnish present. The amount and size of particulates present in the system are acceptable.

FLUID DEGRADATION		method	limit/base	current	history1	history2
Acid Number (AN)	mg KOH/g	ASTM D8045		**0.362**	0.366	0.344
MPC Varnish Potential	Scale	ASTM D7843	>15	**51**	56	56.8

We recommend that you use electrostatic filtration to remove insolubles from the oil and to reduce the levels of varnish in the system. Alternatively draining a percentage of the oil and topping up with fresh oil (sweetening the oil) may provide a reduction in the varnish potential level. We recommend an early resample to monitor this condition.

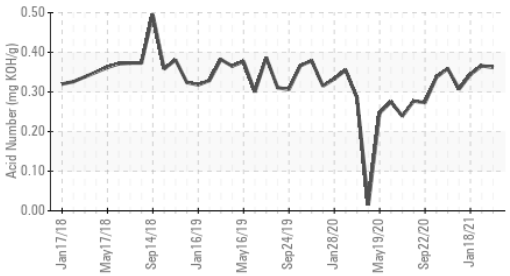
Acid Number

The AN level is acceptable for this fluid.
