Machine Id
STL HEATER
Component
Heat Transfer Fluid
Fluid
THERMINOL 55 (--- GAL)

Customer Id: BLUSTL
Sample No.: TO10000664
Lab Number: 05431747
Test Package: IND 2

OIL ANALYSIS REPORT

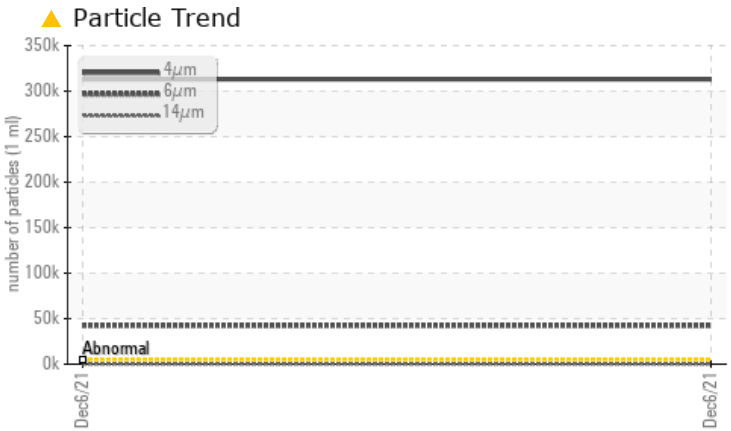
COMPONENT CONDITION SUMMARY

Sample Status				**ABNORMAL**	---	---
Particles >4µm		ASTM D7647	>5000	▲ **312983**	---	---
Particles >6µm		ASTM D7647	>1300	▲ **42370**	---	---
Particles >14µm		ASTM D7647	>160	▲ **234**	---	---
Oil Cleanliness		ISO 4406 (c)	>19/17/14	▲ **25/23/15**	---	---

Contamination
There is a high amount of particulates present in the oil.

We recommend you service the filters on this component. Resample at the next service interval to monitor. Please note that this is a corrected copy for laboratory data updates.

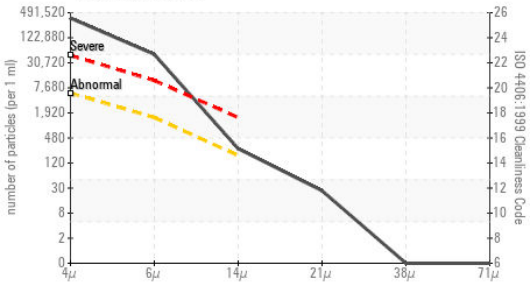
Particle Count

FLUID CLEANLINESS		method	limit/base	current	history1	history2
Particles >4µm		ASTM D7647	>5000	▲ **312983**	---	---
Particles >6µm		ASTM D7647	>1300	▲ **42370**	---	---
Particles >14µm		ASTM D7647	>160	▲ **234**	---	---
Particles >21µm		ASTM D7647	>40	**23**	---	---
Particles >38µm		ASTM D7647	>10	**0**	---	---
Particles >71µm		ASTM D7647	>3	**0**	---	---
Oil Cleanliness		ISO 4406 (c)	>19/17/14	▲ **25/23/15**	---	---

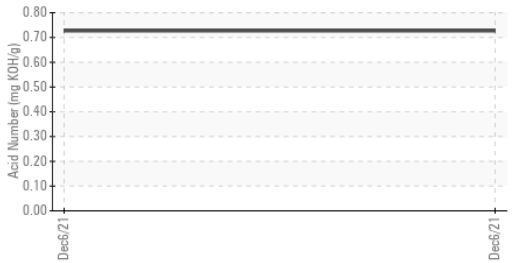
Fluid Condition
The AN level is acceptable for this fluid. The condition of the oil is suitable for further service.

FLUID DEGRADATION		method	limit/base	current	history1	history2
Acid Number (AN)	mg KOH/g	ASTM D8045		**0.727**	---	---

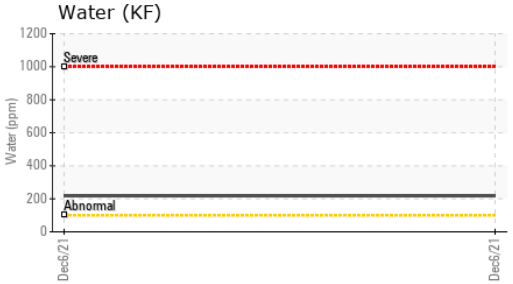
Water (KF)

CONTAMINANTS		method	limit/base	current	history1	history2
Silicon	ppm	ASTM D5185m		**0**	---	---
Sodium	ppm	ASTM D5185m		**0**	---	---
Potassium	ppm	ASTM D5185m	>20	**0**	---	---
Water	%	ASTM D6304		**0.021**	---	---
ppm Water	ppm	ASTM D6304		**218.7**	---	---
