Machine Id
KAESER SK 19 1580236 (S/N 1214)
Component
Compressor
Fluid
KAESER SIGMA (OEM) S-460 (--- GAL)

Customer Id: WARWARMO
Sample No.: KCP49247
Lab Number: 05664151
Test Package: IND 2

OIL ANALYSIS REPORT

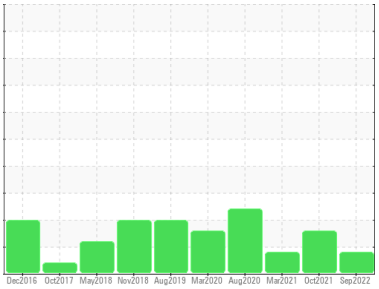
Sample Rating Trend

ATTENTION	ABNORMAL	ATTENTION
Sample Status				**ATTENTION**	ABNORMAL	ATTENTION
Particles >14µm		ASTM D7647	>80	▲ **81**	▲ 501	▲ 87
Oil Cleanliness		ISO 4406 (c)	>--/17/13	▲ **20/17/14**	▲ 19/16	▲ 16/14

No corrective action is recommended at this time. Oil and filter change at the time of sampling has been noted. Resample at the next service interval to monitor.

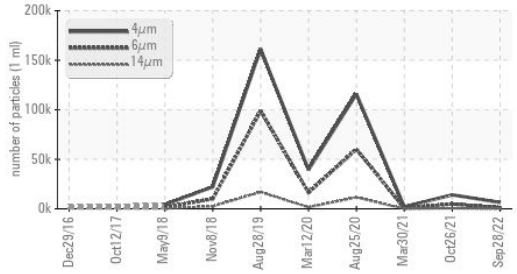
Particle Trend

Contamination
There is a moderate amount of particulates present in the oil.

FLUID CLEANLINESS		method	limit/base	current	history1	history2
Particles >4µm		ASTM D7647		**6415**	14085	2060
Particles >6µm		ASTM D7647	>1300	**1079**	▲ 4778	634
Particles >14µm		ASTM D7647	>80	▲ **81**	▲ 501	▲ 87
Particles >21µm		ASTM D7647	>20	**15**	▲ 144	▲ 30
Particles >38µm		ASTM D7647	>4	**1**	▲ 5	1
Particles >71µm		ASTM D7647	>3	**0**	0	0
Oil Cleanliness		ISO 4406 (c)	>--/17/13	▲ **20/17/14**	▲ 19/16	▲ 16/14

Recommendation
No corrective action is recommended at this time. Oil and filter change at the time of sampling has been noted. Resample at the next service interval to monitor.

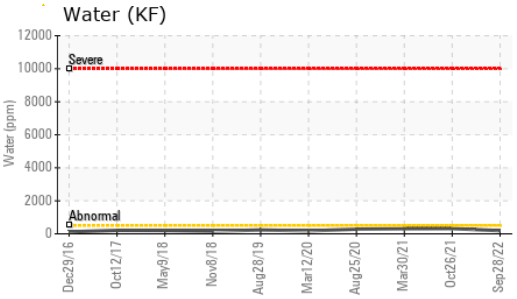
Water (KF)

CONTAMINANTS		method	limit/base	current	history1	history2
Silicon	ppm	ASTM D5185m	>25	**<1**	0	0
Sodium	ppm	ASTM D5185m		**21**	19	20
Potassium	ppm	ASTM D5185m	>20	**3**	2	2
Water	%	ASTM D6304	>0.05	**0.019**	0.031	0.030
ppm Water	ppm	ASTM D6304	>500	**190.1**	318.8	308.7

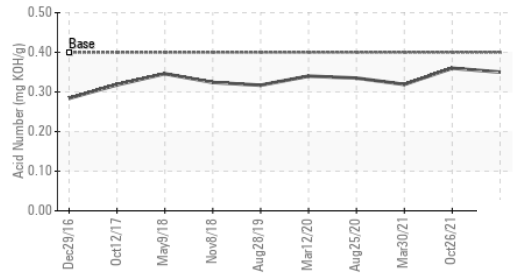
Fluid Condition
The AN level is acceptable for this fluid. The condition of the oil is suitable for further service.

FLUID DEGRADATION		method	limit/base	current	history1	history2
Acid Number (AN)	mg KOH/g	ASTM D8045	0.4	**0.35**	0.360	0.319

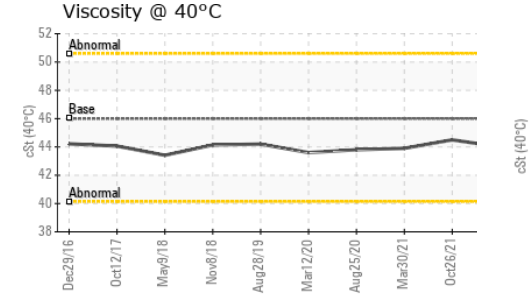
Viscosity @ 40°C

FLUID PROPERTIES		method	limit/base	current	history1	history2
Visc @ 40°C	cSt	ASTM D445	46	**44.0**	44.5	43.9

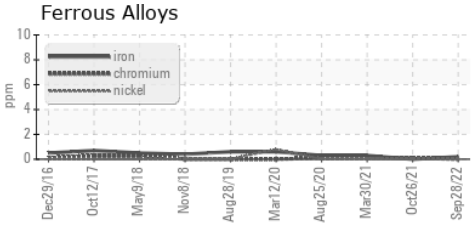
Ferrous Alloys

Wear
All component wear rates are normal.
