Machine Id
ADS 4
Component
Gearbox
Fluid
SUMMIT SH 7150 (3 GAL)

Customer Id: FLAMONNC
Sample No.: WC0668059
Lab Number: 05690173
Test Package: IND 2

OIL ANALYSIS REPORT

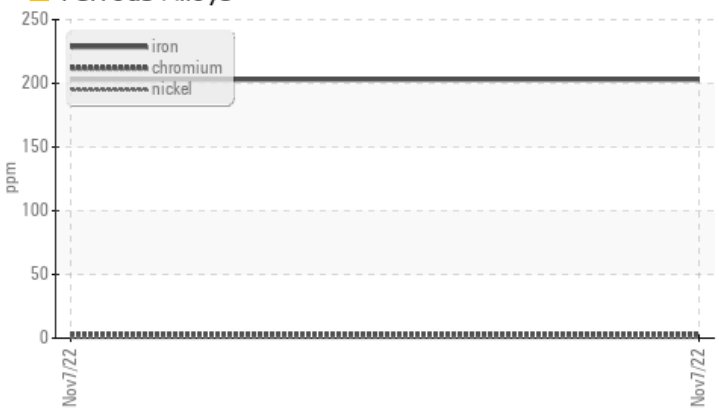
Ferrous Alloys

Sample Status				**ABNORMAL**	---	---
Iron	ppm	ASTM D5185m	>200	▲ **203**	---	---
Particles >4µm		ASTM D7647	>20000	▲ **153182**	---	---
Particles >6µm		ASTM D7647	>5000	▲ **25596**	---	---
Oil Cleanliness		ISO 4406 (c)	>21/19/16	▲ **24/22/15**	---	---

Wear
The iron level is abnormal. All other component wear rates are normal.

We recommend you service the filters on this component if applicable. Resample at the next service interval to monitor.

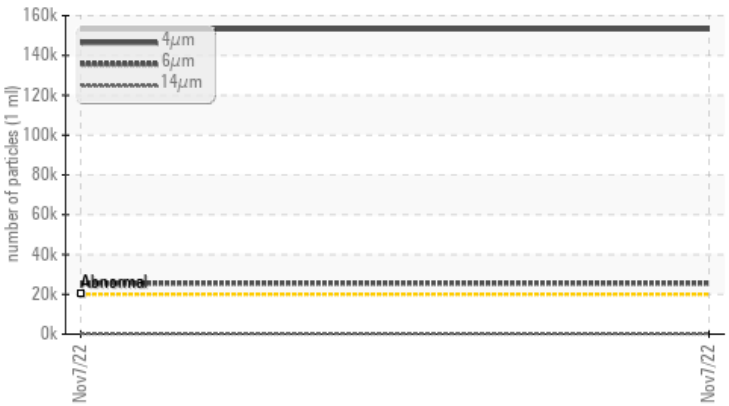
Particle Trend

Contamination
There is a high amount of silt (particulates < 14 microns in size) present in the oil.

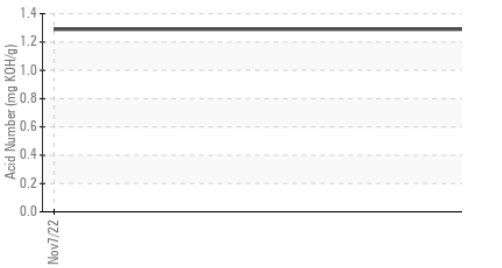
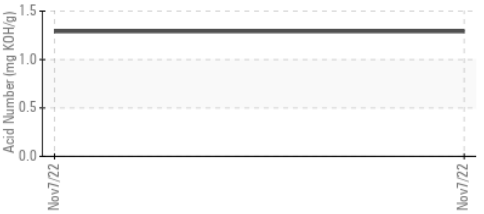
Fluid Condition
The AN level is acceptable for this fluid. The condition of the oil is acceptable for the time in service.

FLUID DEGRADATION		method	limit/base	current	history1	history2
Acid Number (AN)	mg KOH/g	ASTM D8045		**1.29**	---	---

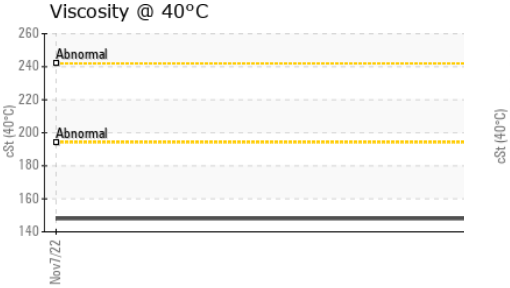
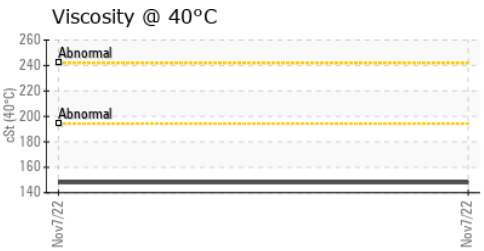
Viscosity @ 40°C

FLUID PROPERTIES		method	limit/base	current	history1	history2
Visc @ 40°C	cSt	ASTM D445		**148**	---	---

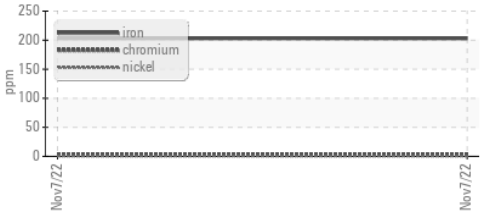
Ferrous Alloys

WEAR METALS		method	limit/base	current	history1	history2
Iron	ppm	ASTM D5185m	>200	▲ **203**	---	---
Chromium	ppm	ASTM D5185m	>15	**2**	---	---
Nickel	ppm	ASTM D5185m	>15	**<1**	---	---
Titanium	ppm	ASTM D5185m		**0**	---	---
Silver	ppm	ASTM D5185m		**<1**	---	---
Aluminum	ppm	ASTM D5185m	>25	**<1**	---	---
Lead	ppm	ASTM D5185m	>100	**0**	---	---
Copper	ppm	ASTM D5185m	>200	**<1**	---	---
Tin	ppm	ASTM D5185m	>25	**<1**	---	---
Vanadium	ppm	ASTM D5185m		**0**	---	---
Cadmium	ppm	ASTM D5185m		**0**	---	---

Recommendation
We recommend you service the filters on this component if applicable. Resample at the next service interval to monitor.
