Customer Id: TAPFRA
Sample No.: RP0029312
Lab Number: 05765891
Test Package: PLANT

OIL ANALYSIS REPORT

Machine Id
LINE 7 SIDE (S/N X56A0100045)
Component
Gearbox
Fluid
SHELL OMALA 320 (--- GAL)

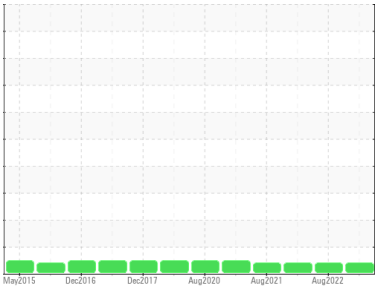
Sample Rating Trend

VIS DEBRIS

Contamination
Moderate concentration of visible dirt/debris present in the oil.

No corrective action is recommended at this time.
Resample at the next service interval to monitor.
