Customer Id: TAPFRA
Sample No.: RP0029315
Lab Number: 05765902
Test Package: PLANT

OIL ANALYSIS REPORT

Machine Id
LINE 9 MAIN (S/N E02A0100034)
Component
Gearbox
Fluid
SHELL OMALA 320 (35 GAL)

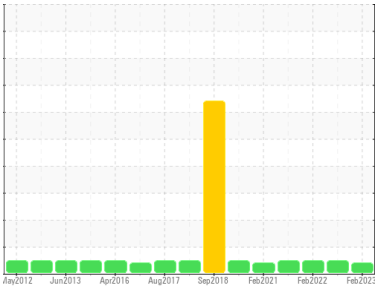
Sample Rating Trend

VIS DEBRIS

Contamination
Moderate concentration of visible dirt/debris present in the oil.

No corrective action is recommended at this time.
Resample at the next service interval to monitor.

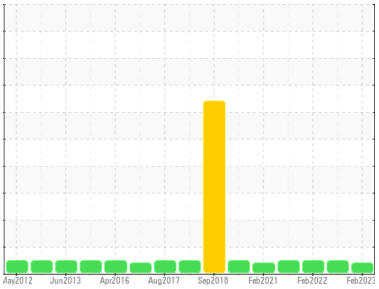
Sample Rating Trend

VIS DEBRIS

Recommendation
No corrective action is recommended at this time. Resample at the next service interval to monitor.
