Machine Id
TS03-07
Component
Hydraulic System
Fluid
NOT GIVEN (--- GAL)

Customer Id: PARLITGA
Sample No.: PH0000365
Lab Number: 05787330
Test Package: PLANT

OIL ANALYSIS REPORT

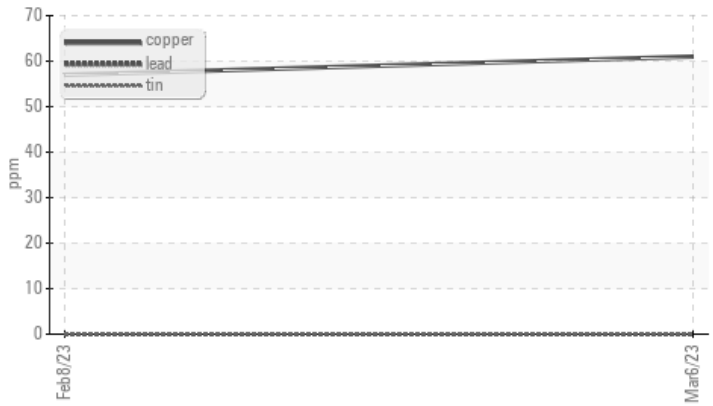
▲ Non-ferrous Metals

Wear
The copper level is abnormal. All other component wear rates are normal.

We recommend you service the filters on this component if applicable. Resample at the next service interval to monitor.

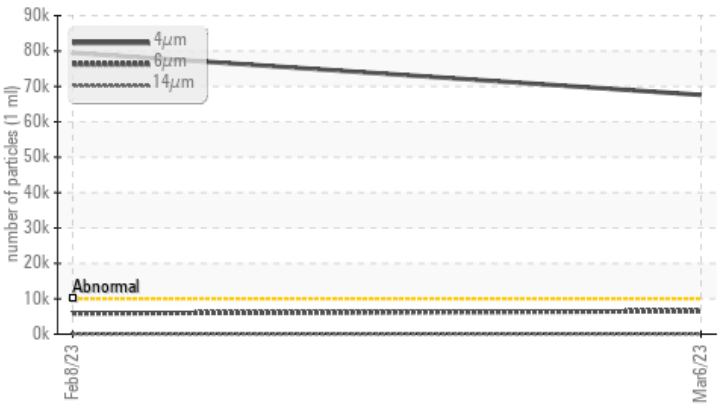
▲ Particle Trend

Contamination
There is a high amount of silt (particulates < 14 microns in size) present in the oil.

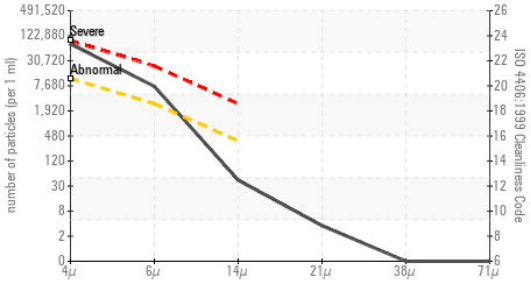
Particle Count

FLUID CLEANLINESS		method	limit/base	current	history1	history2
Particles >4µm		ASTM D7647	>10000	▲ **67603**	▲ 79494	---
Particles >6µm		ASTM D7647	>2500	▲ **6504**	▲ 5879	---
Particles >14µm		ASTM D7647	>320	**37**	23	---
Particles >21µm		ASTM D7647	>80	**3**	2	---
Particles >38µm		ASTM D7647	>20	**0**	0	---
Particles >71µm		ASTM D7647	>4	**0**	0	---
Oil Cleanliness		ISO 4406 (c)	>20/18/15	▲ **23/20/12**	▲ 23/20/12	---
