Machine Id
VILTER CCUP-FGC
Component
Compressor
Fluid
{not provided} (--- GAL)

Customer Id: NORRALNC
Sample No.: WC0782170
Lab Number: 05798296
Test Package: AOM 1

OIL ANALYSIS REPORT

NORTH CAROLINA STATE UNIVERSITY
621 MOTOR POOL DR, FACILITIES DIVISION WAREHOUSE
RALEIGH, NC
US 27607
Contact: PAUL WALKER
apwalke3@ncsu.edu
T: (919)513-3646
F:

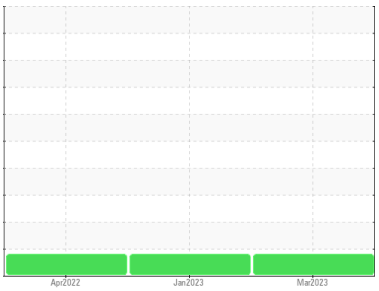
Sample Rating Trend

Sample Status				**SEVERE**	SEVERE	ATTENTION
MPC Varnish Potential	Scale	ASTM D7843	>15	▲ **52**	▲ 59	▲ 23

We recommend that you use electrostatic or in-depth filtration to remove insolubles from the oil and to reduce the levels of varnish in the system. Alternatively draining a percentage of the oil and topping up with fresh oil (sweetening the oil) may provide a reduction in the varnish potential level. We recommend an early resample to monitor this condition.

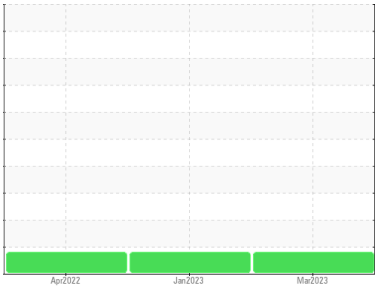
Sample Rating Trend

Contamination
MPC (Membrane Patch Colorimetry) test indicates a high concentration of varnish present. The water content is negligible. The amount and size of particulates present in the system are acceptable.

Recommendation
We recommend that you use electrostatic or in-depth filtration to remove insolubles from the oil and to reduce the levels of varnish in the system. Alternatively draining a percentage of the oil and topping up with fresh oil (sweetening the oil) may provide a reduction in the varnish potential level. We recommend an early resample to monitor this condition.

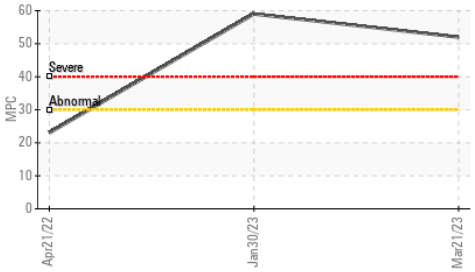
FLUID DEGRADATION		method	limit/base	current	history1	history2
Acid Number (AN)	mg KOH/g	ASTM D8045		**0.12**	0.17	0.29
Anti-Oxidant 1	%	ASTM D6971	<25	**68**	94	---
Anti-Oxidant 2	%	ASTM D6971	<25	**29**	35	---
MPC Varnish Potential	Scale	ASTM D7843	>15	▲ **52**	▲ 59	▲ 23

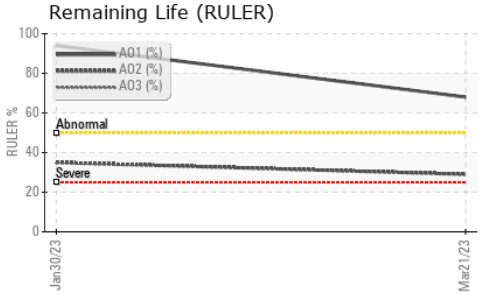
Remaining Life (RULER)

Fluid Condition
The AN level is acceptable for this fluid. Linear Sweep Voltammetry (RULER – ASTM D6971) testing indicates normal levels of anti-oxidants present in the oil.

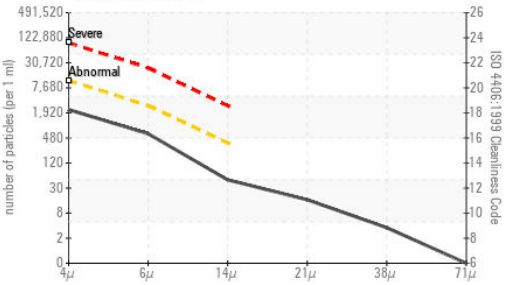
Particle Count

FLUID CLEANLINESS		method	limit/base	current	history1	history2
Particles >4µm		ASTM D7647	>10000	**2015**	8156	9008
Particles >6µm		ASTM D7647	>2500	**532**	946	2506
Particles >14µm		ASTM D7647	>320	**42**	85	230
Particles >21µm		ASTM D7647	>80	**14**	27	80
Particles >38µm		ASTM D7647	>20	**3**	1	4
Particles >71µm		ASTM D7647	>4	**0**	0	0
Oil Cleanliness		ISO 4406 (c)	>20/18/15	**18/16/13**	20/17/14	20/19/15
