Customer Id: BLUDAN
Sample No.: WC0800299
Lab Number: 05799657
Test Package: IND 2

OIL ANALYSIS REPORT

Machine Id
DRY END KILN FAN
Component
Hydraulic System
Fluid
AW HYDRAULIC OIL ISO 68 (5 GAL)

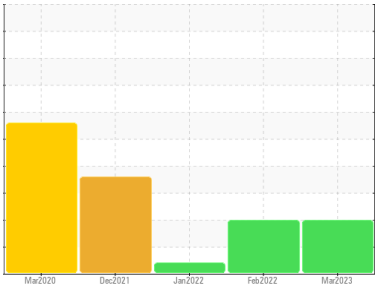
Sample Rating Trend

WATER

We advise that you follow the water drain-off procedure for this component. Resample at the next service interval to monitor. We were unable to perform a particle count due to a high concentration of particles present in this sample.

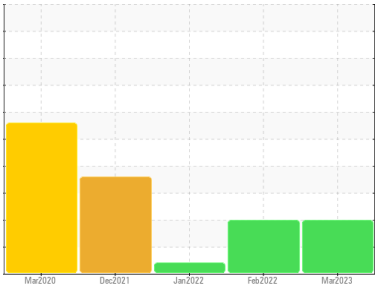
Sample Rating Trend

WATER

Moderate concentration of visible dirt/debris present in the oil. Free water present.

We advise that you follow the water drain-off procedure for this component. Resample at the next service interval to monitor. We were unable to perform a particle count due to a high concentration of particles present in this sample.
