PROBLEM SUMMARY

Area
EBAY
Machine Id
CD6MGB
Component
Main Gearbox
Fluid
MOBIL MOBILGEAR 600 XP ISO100 (40 GAL)

OIL ANALYSIS REPORT

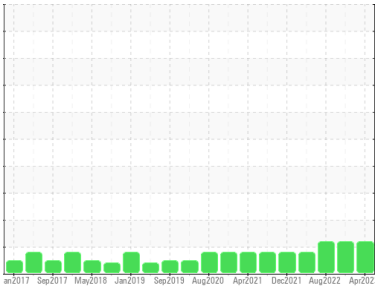
Sample Rating Trend

▲ Contamination
There is a moderate amount of silt (particulates < 14 microns in size) present in the oil.

FLUID CLEANLINESS		method	limit/base	current	history1	history2
Particles >4µm		ASTM D7647	>40000	▲ **61621**	▲ 90837	▲ 97898
Particles >6µm		ASTM D7647	>5000	▲ **5814**	▲ 14077	▲ 8070
Particles >14µm		ASTM D7647	>640	**34**	111	72
Particles >21µm		ASTM D7647	>160	**3**	8	12
Particles >38µm		ASTM D7647	>40	**0**	0	0
Particles >71µm		ASTM D7647	>10	**0**	0	0
Oil Cleanliness		ISO 4406 (c)	>22/19/16	▲ **23/20/12**	▲ 24/21/14	▲ 24/20/13

Resample at the next service interval to monitor. Due to an abnormal test result it is recommended to contact Stauff Corp at (201)-444-7800 for help resolving the issue.

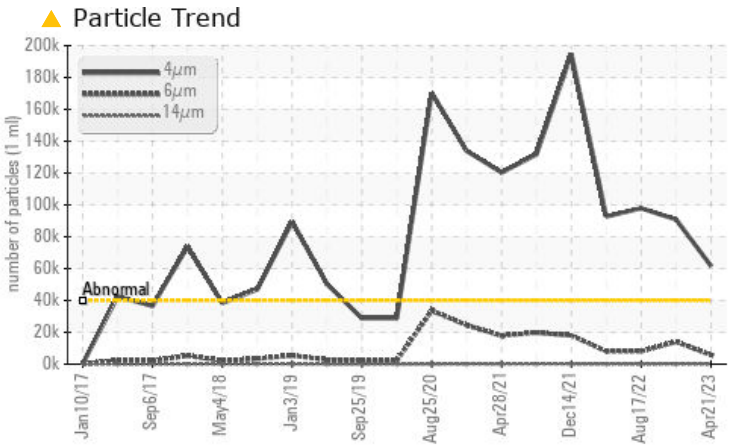
COMPONENT CONDITION SUMMARY

Sample Status				ATTENTION	ABNORMAL	ABNORMAL
Particles >4µm		ASTM D7647	>40000	▲ **61621**	▲ 90837	▲ 97898
Particles >6µm		ASTM D7647	>5000	▲ **5814**	▲ 14077	▲ 8070
Oil Cleanliness		ISO 4406 (c)	>22/19/16	▲ **23/20/12**	▲ 24/21/14	▲ 24/20/13
