Machine Id
KAESER SX 5 4456603 (S/N 1088)
Component
Compressor
Fluid
KAESER SIGMA (OEM) M-460 (--- GAL)

Customer Id: OLDLAS
Sample No.: KCP52319
Lab Number: 05850652
Test Package: IND 2

OIL ANALYSIS REPORT

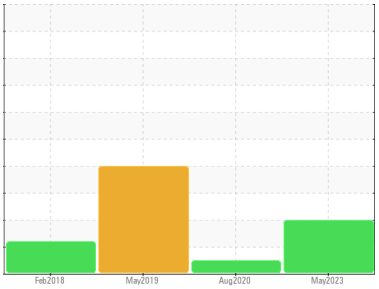
Sample Rating Trend

WATER

Contamination
Moderate concentration of visible dirt/debris present in the oil. There is a light concentration of water present in the oil.

Oil and filter change at the time of sampling has been noted. We were unable to perform a particle count due to a high concentration of particles present in this sample. We recommend an early resample in 500 hours to monitor this condition.
