OIL ANALYSIS REPORT

Area
13
Machine Id
ECHESA WTG-1302 (S/N 4836490-0020-6)
Component
Wind Turbine Gearbox
Fluid
SHELL OMALA 320 (340 LTR)

FERROGRAPHY REPORT

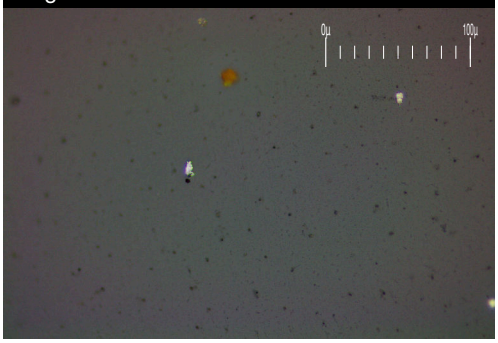
Magn: 500x Illum: RW

Recommendation
Resample at the next service interval to monitor. Analytical Ferrography: Results indicate normal operation, with typical amounts of ferrous rubbing wear and contamination. There is a single ferrous sliding wear particle that does not appear to be related to any active wear issue.
