Area
3
Machine Id
WINERGY GEARBOX WTG-301 (S/N 4836490-0020-5)
Component
Wind Turbine Gearbox
Fluid
FUCHS RENOLIN UNISYN CKC ISO 320 (340 LTR)

Customer Id: ENEFRA
Sample No.: WC0804437
Lab Number: 05857865
Test Package: IND 2

OIL ANALYSIS REPORT

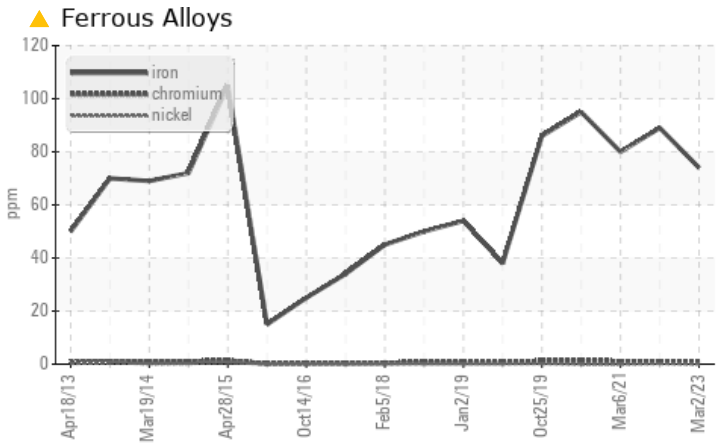
COMPONENT CONDITION SUMMARY

No corrective action is recommended at this time. Resample at the next service interval to monitor. Analytical Ferrography: Results indicate normal operation, with typical amounts of ferrous rubbing wear and contamination present. Iron in the metals analysis is not present as wear in the Ferrography, and the result has been stable and downward trending, suggesting that this wear is likely submicron-sized and present from time on oil or a similar issue more than any actual wear concern.

Sample Status				**MARGINAL**	ABNORMAL	ABNORMAL
Iron	ppm	ASTM D5185m	>65	▲ **74**	▲ 89	▲ 80
PrtFilter					*no image*	*no image*

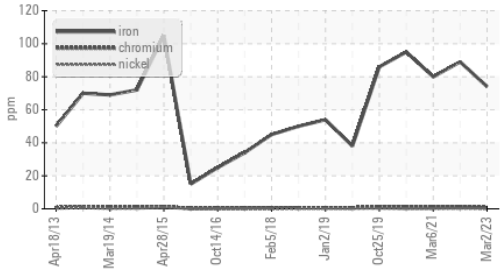
Ferrous Alloys

Gear wear is indicated.

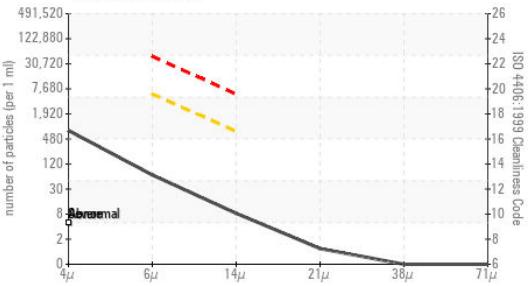
Particle Count

FLUID CLEANLINESS		method	limit/base	current	history1	history2
Particles >4µm		ASTM D7647		**676**	3818	246
Particles >6µm		ASTM D7647	>5000	**58**	302	67
Particles >14µm		ASTM D7647	>640	**7**	16	11
Particles >21µm		ASTM D7647	>160	**1**	5	6
Particles >38µm		ASTM D7647	>40	**0**	0	0
Particles >71µm		ASTM D7647	>10	**0**	0	0
Oil Cleanliness		ISO 4406 (c)	>--/19/16	**17/13/10**	19/15/11	15/13/11

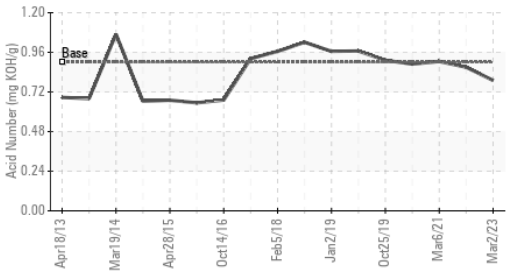
The AN level is acceptable for this fluid. The condition of the oil is suitable for further service.

FLUID DEGRADATION		method	limit/base	current	history1	history2
Acid Number (AN)	mg KOH/g	ASTM D8045	0.9	**0.79**	0.87	0.905

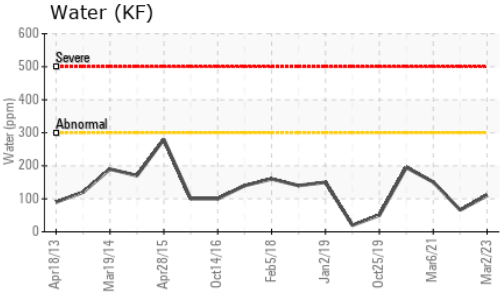
Water (KF)

CONTAMINANTS		method	limit/base	current	history1	history2
Silicon	ppm	ASTM D5185m	>15	**0**	0	0
Sodium	ppm	ASTM D5185m		**3**	1	3
Potassium	ppm	ASTM D5185m	>20	**<1**	0	6
Water	%	ASTM D6304	>0.03	**0.011**	0.006	0.015
ppm Water	ppm	ASTM D6304	>300	**110.0**	66.0	150.9

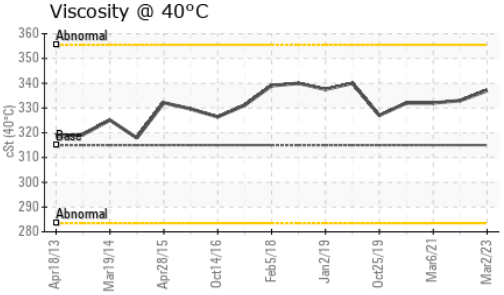
Viscosity @ 40°C

FLUID PROPERTIES		method	limit/base	current	history1	history2
Visc @ 40°C	cSt	ASTM D445	315	**337**	333	332

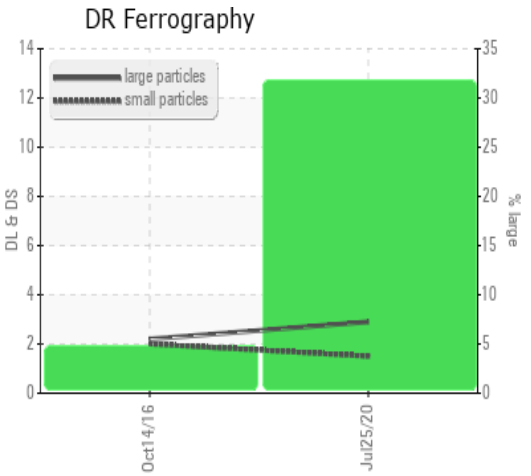
WEAR

Gear wear is indicated.
