Area
1
Machine Id
WINERGY GEARBOX WTG-103 (S/N 4839491-0020-6)
Component
Wind Turbine Gearbox
Fluid
FUCHS RENOLIN UNISYN CKC ISO 320 (340 LTR)

Customer Id: ENEFRA
Sample No.: WC0804462
Lab Number: 05857915
Test Package: IND 2

OIL ANALYSIS REPORT

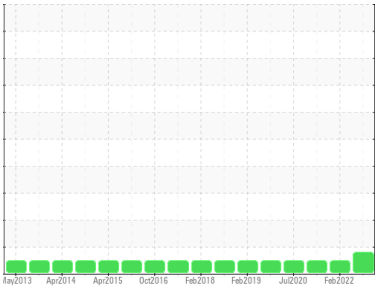
Sample Rating Trend

SEDIMENT

Sample Status				**ABNORMAL**	NORMAL	NORMAL
Silt	scalar	*Visual	NONE	▲ **HEAVY**	NONE	NONE

There is a high amount of visible silt present in the sample.

We recommend you service the filters on this component. Resample at the next service interval to monitor. We were unable to perform a particle count due to a high concentration of particles present in this sample.

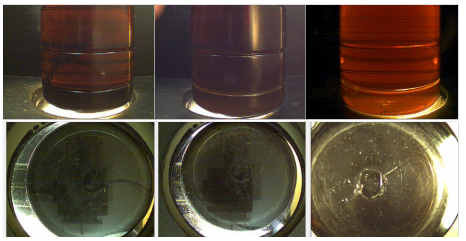
SAMPLE IMAGES	method	limit/base	current	history1	history2
Color					
Bottom

VISUAL		method	limit/base	current	history1	history2
White Metal	scalar	*Visual	NONE	**NONE**	NONE	NONE
Yellow Metal	scalar	*Visual	NONE	**NONE**	NONE	NONE
Precipitate	scalar	*Visual	NONE	**NONE**	NONE	NONE
Silt	scalar	*Visual	NONE	▲ **HEAVY**	NONE	NONE
Debris	scalar	*Visual	NONE	**NONE**	NONE	NONE
Sand/Dirt	scalar	*Visual	NONE	**NONE**	NONE	NONE
Appearance	scalar	*Visual	NORML	**NORML**	NORML	NORML
Odor	scalar	*Visual	NORML	**NORML**	NORML	NORML
Emulsified Water	scalar	*Visual	>0.03	**NEG**	NEG	NEG
Free Water	scalar	*Visual		**NEG**	NEG	NEG
