Customer Id: ENEFRA
Sample No.: WC0804469
Lab Number: 05857932
Test Package: IND 2

OIL ANALYSIS REPORT

Area
7
Machine Id
WINERGY GEARBOX WTG-702 (S/N 4834564-0020-3)
Component
Wind Turbine Gearbox
Fluid
FUCHS RENOLIN UNISYN CKC ISO 320 (340 LTR)

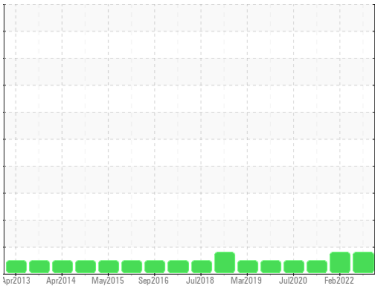
Sample Rating Trend

WEAR

Sample Status				**ABNORMAL**	ABNORMAL	NORMAL
Iron	ppm	ASTM D5185m	>65	▲ **96**	▲ 85	57

No corrective action is recommended at this time.
Resample at the next service interval to monitor.

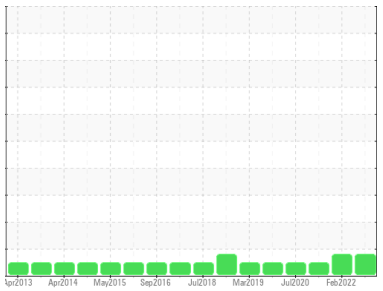
Sample Rating Trend

WEAR

Wear
The iron level is abnormal. All other component wear rates are normal.

Contamination
The amount and size of particulates present in the system are acceptable. There is no indication of any contamination in the oil.

Fluid Condition
The AN level is acceptable for this fluid. The condition of the oil is suitable for further service.

Recommendation
No corrective action is recommended at this time. Resample at the next service interval to monitor.
