Customer Id: OWEGOD
Sample No.: KCPA002301
Lab Number: 05874532
Test Package: IND 2

OIL ANALYSIS REPORT

Machine Id
7428784 (S/N 1041)
Component
Compressor
Fluid
KAESER SIGMA (OEM) S-460 (--- GAL)

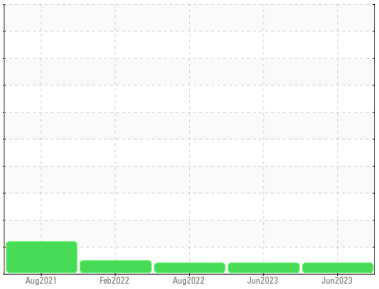
Sample Rating Trend

VIS DEBRIS

Contamination
High concentration of visible dirt/debris present in the oil.

No corrective action is recommended at this time. The filter change at the time of sampling has been noted. Resample at the next service interval to monitor. We were unable to perform a particle count due to a high concentration of particles present in this sample.

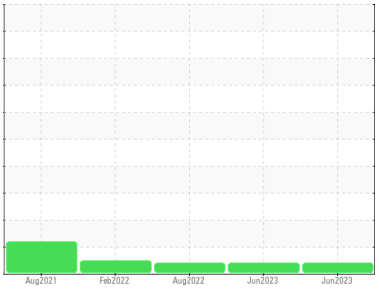
Sample Rating Trend

VIS DEBRIS

Recommendation
No corrective action is recommended at this time. The filter change at the time of sampling has been noted. Resample at the next service interval to monitor. We were unable to perform a particle count due to a high concentration of particles present in this sample.
