PROBLEM SUMMARY

OIL ANALYSIS REPORT

Machine Id
KAESER AS 30 6142903 (S/N 1053)
Component
Compressor
Fluid
KAESER SIGMA (OEM) M-460 (--- GAL)

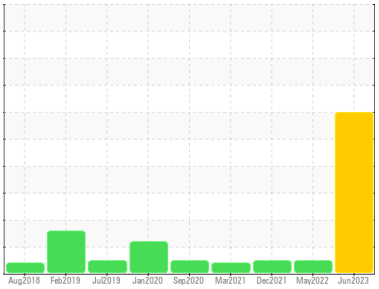
Sample Rating Trend

WATER

The filter change at the time of sampling has been noted. We were unable to perform a particle count due to a high concentration of particles present in this sample. We advise that you stop the unit and follow the water drain-off procedure for this component. We recommend an early resample in 500 hours to monitor this condition.

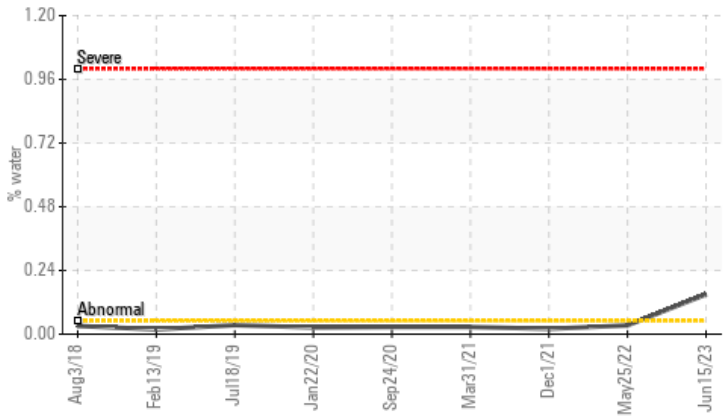
Sample Status				**ABNORMAL**	NORMAL	NORMAL
Water	%	ASTM D6304	>0.05	▲ **0.150**	0.033	0.020
ppm Water	ppm	ASTM D6304	>500	▲ **1500**	339.5	208.5
Particles >6µm		ASTM D7647	>1300	▲ **2162**	671	1217
Particles >14µm		ASTM D7647	>80	▲ **171**	35	37
Particles >21µm		ASTM D7647	>20	▲ **37**	11	6
Oil Cleanliness		ISO 4406 (c)	>--/17/13	▲ **20/18/15**	19/17/12	17/12
Debris	scalar	*Visual	NONE	▲ **MODER**	NONE	NONE
Appearance	scalar	*Visual	NORML	▲ **HAZY**	NORML	NORML
Emulsified Water	scalar	*Visual	>0.05	▲ **0.2%**	NEG	NEG
Free Water	scalar	*Visual		▲ **1.0**	NEG	NEG

Contamination
Moderate concentration of visible dirt/debris present in the oil. There is a light concentration of water present in the oil. Free water present.

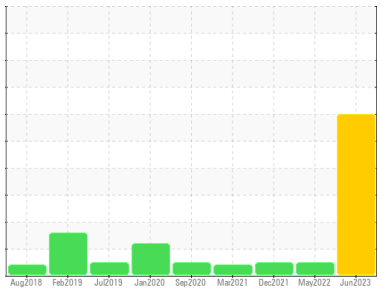
Sample Rating Trend

WATER

Recommendation
The filter change at the time of sampling has been noted. We were unable to perform a particle count due to a high concentration of particles present in this sample. We advise that you stop the unit and follow the water drain-off procedure for this component. We recommend an early resample in 500 hours to monitor this condition.

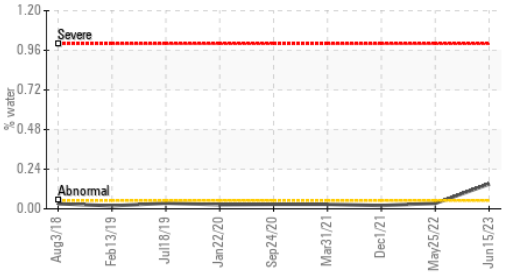
CONTAMINANTS		method	limit/base	current	history1	history2
Silicon	ppm	ASTM D5185m	>25	**0**	0	0
Sodium	ppm	ASTM D5185m		**3**	14	27
Potassium	ppm	ASTM D5185m	>20	**2**	<1	2
Water	%	ASTM D6304	>0.05	▲ **0.150**	0.033	0.020
ppm Water	ppm	ASTM D6304	>500	▲ **1500**	339.5	208.5

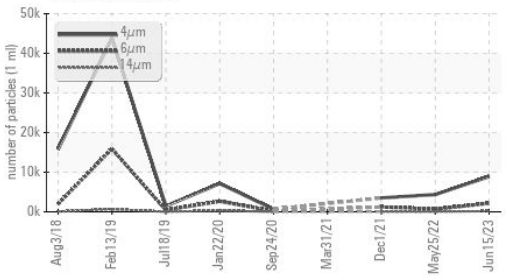
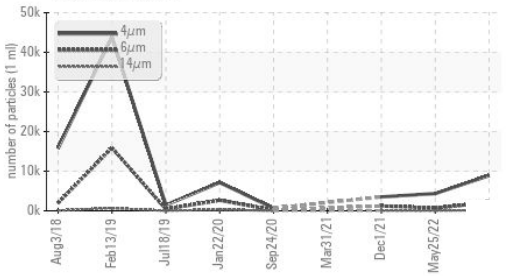
Particle Trend

FLUID CLEANLINESS		method	limit/base	current	history1	history2
Particles >4µm		ASTM D7647		**8896**	4354	3502
Particles >6µm		ASTM D7647	>1300	▲ **2162**	671	1217
Particles >14µm		ASTM D7647	>80	▲ **171**	35	37
Particles >21µm		ASTM D7647	>20	▲ **37**	11	6
Particles >38µm		ASTM D7647	>4	**1**	1	0
Particles >71µm		ASTM D7647	>3	**0**	0	0
Oil Cleanliness		ISO 4406 (c)	>--/17/13	▲ **20/18/15**	19/17/12	17/12

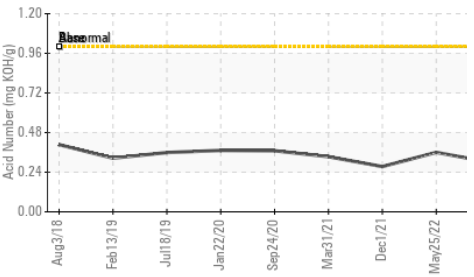
Acid Number

Fluid Condition
The AN level is acceptable for this fluid.

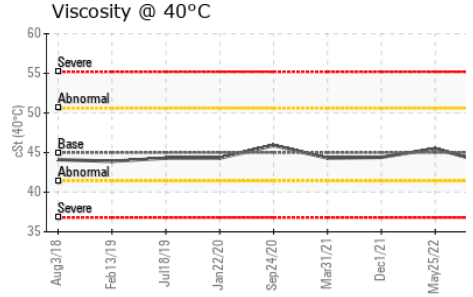
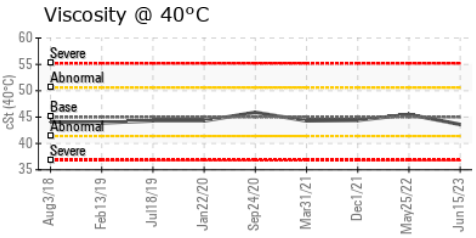
Viscosity @ 40°C

FLUID PROPERTIES		method	limit/base	current	history1	history2
Visc @ 40°C	cSt	ASTM D445	45	**43.6**	45.5	44.4

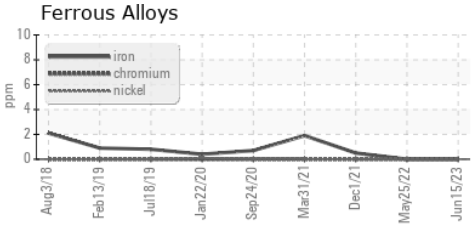
Ferrous Alloys

Wear
All component wear rates are normal.

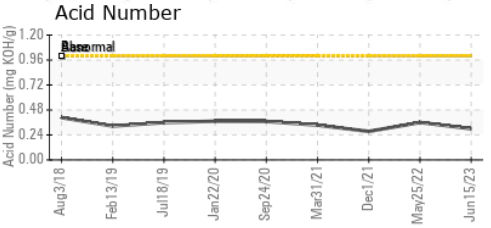
FLUID DEGRADATION		method	limit/base	current	history1	history2
Acid Number (AN)	mg KOH/g	ASTM D8045	1.0	**0.30**	0.36	0.274
