Customer Id: EASCONCA
Sample No.: KCPA002330
Lab Number: 05879565
Test Package: IND 2

OIL ANALYSIS REPORT

Machine Id
4047602 (S/N 6667)
Component
Compressor
Fluid
KAESER SIGMA (OEM) M-460 (--- GAL)

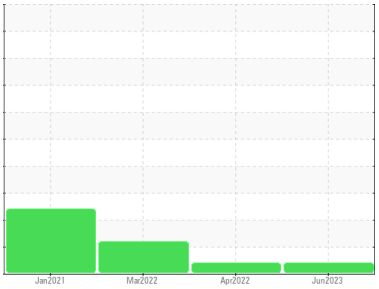
Sample Rating Trend

VIS DEBRIS

Contamination
Moderate concentration of visible dirt/debris present in the oil.

No corrective action is recommended at this time. The filter change at the time of sampling has been noted. Resample at the next service interval to monitor. We were unable to perform a particle count due to a high concentration of particles present in this sample.

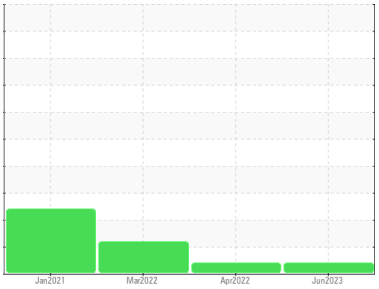
Sample Rating Trend

VIS DEBRIS

Recommendation
No corrective action is recommended at this time. The filter change at the time of sampling has been noted. Resample at the next service interval to monitor. We were unable to perform a particle count due to a high concentration of particles present in this sample.
