Machine Id
## KAESER SX 5 5377583 (S/N 1834)
Component
**Compressor**
Fluid
**KAESER SIGMA (OEM) S-460 (--- GAL)**

# OIL ANALYSIS REPORT

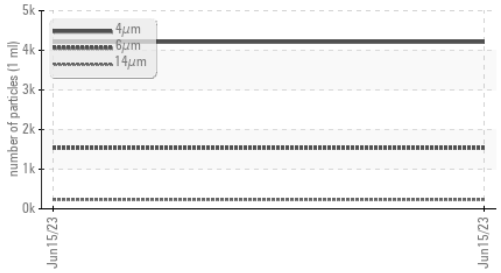
Particle Trend

**Contamination**
There is a high amount of particulates present in the oil.

| FLUID CLEANLINESS | method | limit/base | current | history1 | history2 |
|---|---|---|---|---|---|
| Particles >6µm | ASTM D7647 | >1300 | ▲ **1535** | --- | --- |
| Particles >14µm | ASTM D7647 | >80 | ▲ **230** | --- | --- |
| Particles >21µm | ASTM D7647 | >20 | ▲ **78** | --- | --- |
| Oil Cleanliness | ISO 4406 (c) | >--/17/13 | ▲ **19/18/15** | --- | --- |

**Recommendation**
No corrective action is recommended at this time. The filter change at the time of sampling has been noted. Resample at the next service interval to monitor.
