PROBLEM SUMMARY

Area
OKLAHOMA/102/EG - AGRICULTURAL EQUIPMENT
Machine Id
69.100L [OKLAHOMA^102^EG - AGRICULTURAL EQUIPMENT]
Component
Steering
Fluid
MOBIL MOBILTRANS AST 30 (--- GAL)

OIL ANALYSIS REPORT

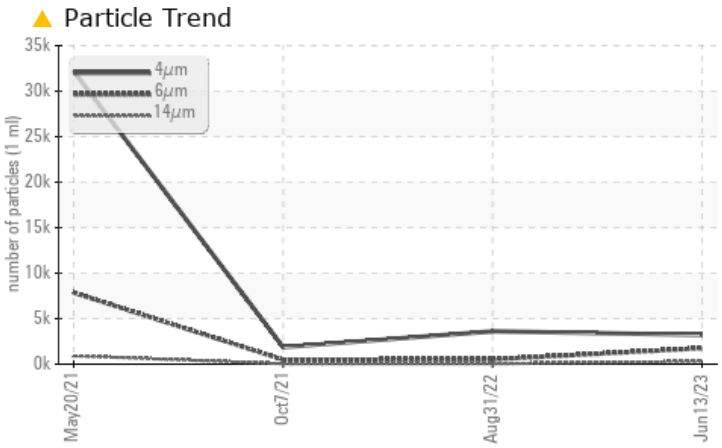
COMPONENT CONDITION SUMMARY

Sample Status				ABNORMAL	NORMAL	NORMAL
Particles >6µm		ASTM D7647	>640	▲ **1749**	519	484
Particles >14µm		ASTM D7647	>80	▲ **298**	38	40
Particles >21µm		ASTM D7647	>20	▲ **100**	10	10
Particles >38µm		ASTM D7647	>4	▲ **15**	0	0
Oil Cleanliness		ISO 4406 (c)	>--/16/13	▲ **19/18/15**	19/16/12	18/16/12

Contamination
There is a high amount of particulates present in the fluid.

No corrective action is recommended at this time. The filter change at the time of sampling has been noted. Resample at the next service interval to monitor.

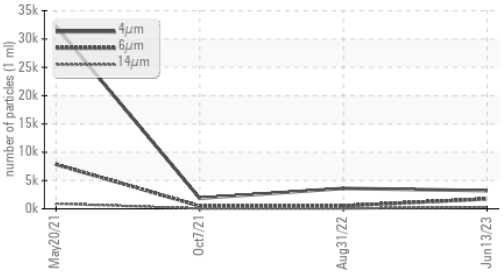
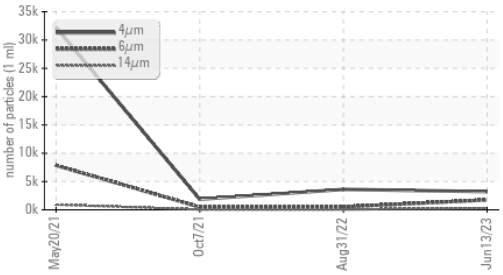
Particle Trend

FLUID CLEANLINESS		method	limit/base	current	history1	history2
Particles >4µm		ASTM D7647		**3210**	3610	1867
Particles >6µm		ASTM D7647	>640	▲ **1749**	519	484
Particles >14µm		ASTM D7647	>80	▲ **298**	38	40
Particles >21µm		ASTM D7647	>20	▲ **100**	10	10
Particles >38µm		ASTM D7647	>4	▲ **15**	0	0
Particles >71µm		ASTM D7647	>3	**2**	0	0
Oil Cleanliness		ISO 4406 (c)	>--/16/13	▲ **19/18/15**	19/16/12	18/16/12

Recommendation
No corrective action is recommended at this time. The filter change at the time of sampling has been noted. Resample at the next service interval to monitor.
