Machine Id
PAO FLUSHING PUMP 0827606
Component
Hydraulic System
Fluid
NOT GIVEN (--- GAL)

Customer Id: TAGBAL
Sample No.: WC0827606
Lab Number: 05899501
Test Package: IND 2

OIL ANALYSIS REPORT

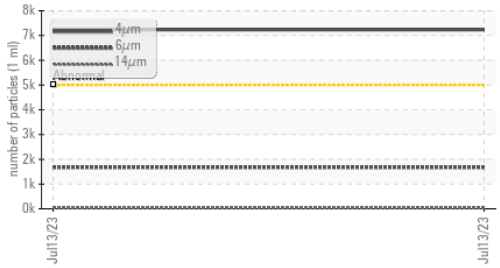
Particle Trend

Contamination
Discrete particle counts [100 ml] 5-15µm = 165400, 15-25µm = 2000, 25-50µm = 400, 50-100µm = 0, >100µm = 0. There is a moderate amount of silt (particulates < 14 microns in size) present in the oil.

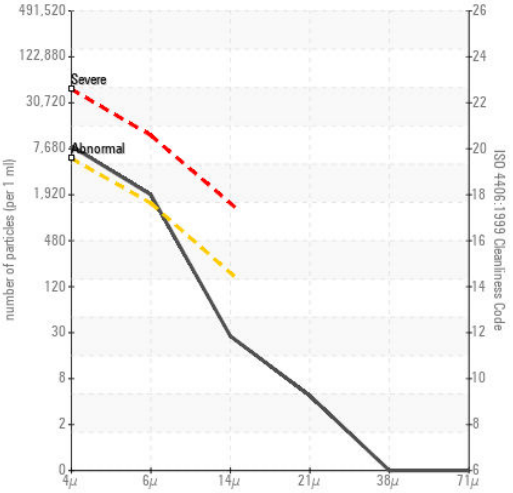
Particle Count

FLUID CLEANLINESS		method	limit/base	current	history1	history2
Particles >4µm		ASTM D7647	>5000	▲ **7233**	---	---
Particles >6µm		ASTM D7647	>1300	▲ **1678**	---	---
Particles >14µm		ASTM D7647	>160	**24**	---	---
Particles >21µm		ASTM D7647	>40	**4**	---	---
Particles >38µm		ASTM D7647	>10	**0**	---	---
Particles >71µm		ASTM D7647	>3	**0**	---	---
Oil Cleanliness		ISO 4406 (c)	>19/17/14	▲ **20/18/12**	---	---

No corrective action is recommended at this time.
Resample at the next service interval to monitor.
