Machine Id
2215
Component
Diesel Engine
Fluid
NOT GIVEN (--- GAL)

Customer Id: IDETAMFL
Sample No.: IL05900951
Lab Number: 05900951
Test Package: FLEET

OIL ANALYSIS REPORT

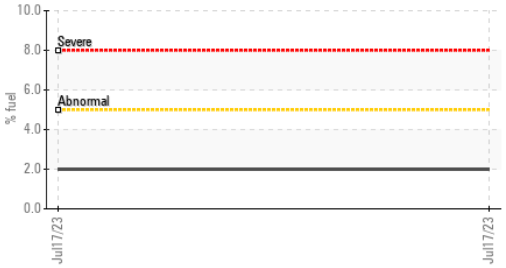
Fuel Dilution

Contamination
Elevated aluminum (Al) and/or lead (Pb) and potassium (K) levels in your metals analysis are likely a result of solder flux release into the lubricant and is common on new equipment/components. Light fuel dilution occurring.

Fluid Condition
The BN result indicates that there is suitable alkalinity remaining in the oil. Fuel is present in the oil and is lowering the viscosity. The condition of the oil is suitable for further service.

CONTAMINANTS		method	limit/base	current	history1	history2
Silicon	ppm	ASTM D5185m	>25	**32**	---	---
Sodium	ppm	ASTM D5185m		**7**	---	---
Potassium	ppm	ASTM D5185m	>20	**345**	---	---
Fuel	%	ASTM D3524	>5	▲ **2.0**	---	---

Resample at the next service interval to monitor. Please specify the component make and model with your next sample. Please specify the brand, type, and viscosity of the oil on your next sample.

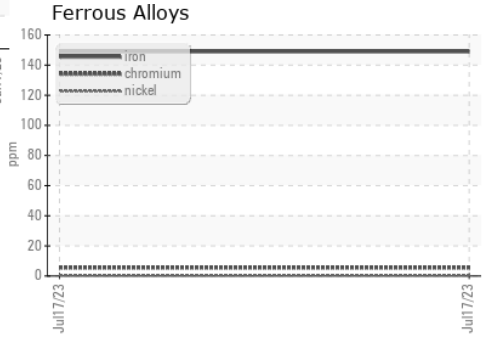
Ferrous Alloys

Wear
Metal levels are typical for a components first oil change.

WEAR METALS		method	limit/base	current	history1	history2
Iron	ppm	ASTM D5185m	>100	**149**	---	---
Chromium	ppm	ASTM D5185m	>20	**6**	---	---
Nickel	ppm	ASTM D5185m	>4	**<1**	---	---
Titanium	ppm	ASTM D5185m		**<1**	---	---
Silver	ppm	ASTM D5185m	>3	**0**	---	---
Aluminum	ppm	ASTM D5185m	>20	**116**	---	---
Lead	ppm	ASTM D5185m	>40	**<1**	---	---
Copper	ppm	ASTM D5185m	>330	**20**	---	---
Tin	ppm	ASTM D5185m	>15	**<1**	---	---
Vanadium	ppm	ASTM D5185m		**<1**	---	---
Cadmium	ppm	ASTM D5185m		**0**	---	---

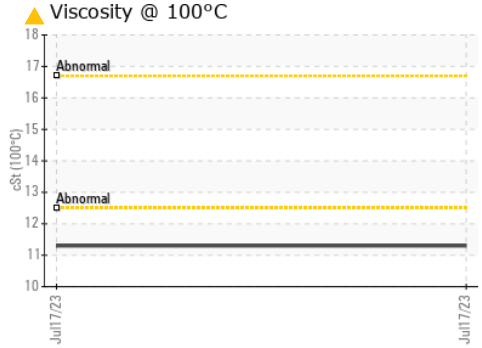
Viscosity @ 100°C

FLUID PROPERTIES		method	limit/base	current	history1	history2
Visc @ 100°C	cSt	ASTM D445		▲ **11.3**	---	---

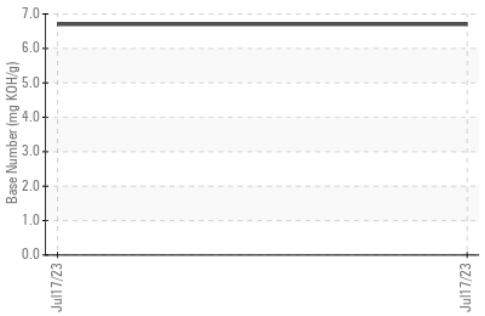
FLUID DEGRADATION		method	limit/base	current	history1	history2
Oxidation	Abs/.1mm	*ASTM D7414	>25	**22.7**	---	---
Base Number (BN)	mg KOH/g	ASTM D2896		**6.7**	---	---
