Area
[186232-N2STV4W]
Machine Id
VALVE PUMP CRJ-700
Component
Hydraulic System
Fluid
MOBIL DTE 24 (200 GAL)

Customer Id: FLIDEN
Sample No.: PH05901855
Lab Number: 05901855
Test Package: PLANT

OIL ANALYSIS REPORT

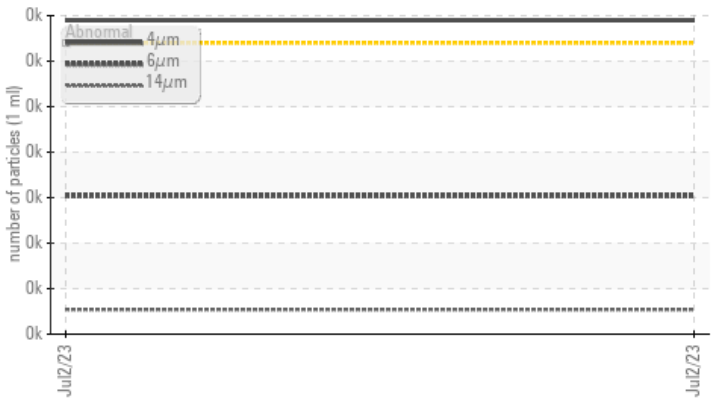
Particle Trend

Sample Status				**ABNORMAL**	---	---
Particles >4µm		ASTM D7647	>320	▲ **345**	---	---
Particles >6µm		ASTM D7647	>80	▲ **152**	---	---
Particles >14µm		ASTM D7647	>10	▲ **27**	---	---
Particles >21µm		ASTM D7647	>3	▲ **9**	---	---
Oil Cleanliness		ISO 4406 (c)	>15/13/10	▲ **16/14/12**	---	---
PrtFilter					*no image*	*no image*

We recommend you service the filters on this component. Resample at the next service interval to monitor.

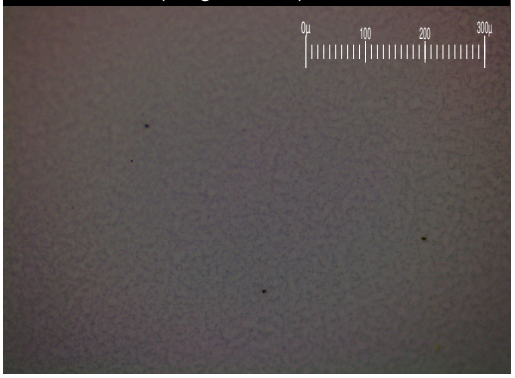
Particle Filter (Magn: 200 x)

Contamination
There is a high amount of particulates present in the oil.

FLUID CLEANLINESS		method	limit/base	current	history1	history2
Particles >4µm		ASTM D7647	>320	▲ **345**	---	---
Particles >6µm		ASTM D7647	>80	▲ **152**	---	---
Particles >14µm		ASTM D7647	>10	▲ **27**	---	---
Particles >21µm		ASTM D7647	>3	▲ **9**	---	---
Particles >38µm		ASTM D7647	>3	**0**	---	---
Particles >71µm		ASTM D7647	>3	**0**	---	---
Oil Cleanliness		ISO 4406 (c)	>15/13/10	▲ **16/14/12**	---	---

Recommendation
We recommend you service the filters on this component. Resample at the next service interval to monitor.
