Area
[23-00343619-000]
Machine Id
HOMOGENIZER HTST 1
Component
Hydraulic System
Fluid
MOBIL DTE 26 (--- GAL)

Customer Id: JACHUT
Sample No.: USP245349
Lab Number: 05901892
Test Package: IND 2

OIL ANALYSIS REPORT

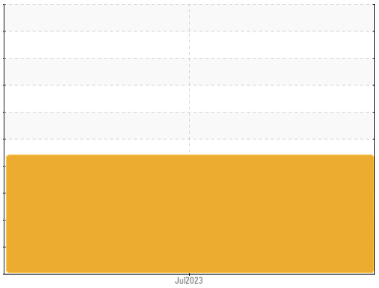
Sample Rating Trend

WATER

Contamination
Excessive free water present. The amount and size of particulates present in the system are acceptable.

We advise that you follow the water drain-off procedure for this component. Resample at the next service interval to monitor.

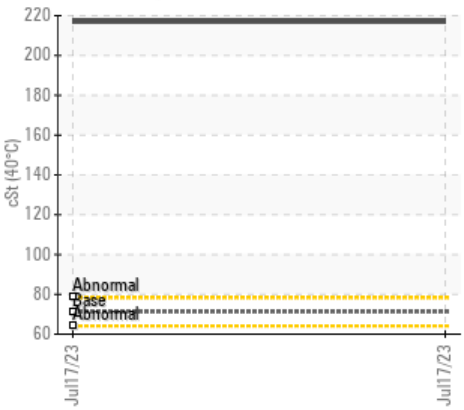
Viscosity @ 40°C

Fluid Condition
The oil viscosity is higher than normal. This plus the additive levels indicates the addition of a different brand or type of oil. Confirmed. The AN level is acceptable for this fluid.

FLUID PROPERTIES		method	limit/base	current	history1	history2
Visc @ 40°C	cSt	ASTM D445	71.2	▲ **217**	---	---

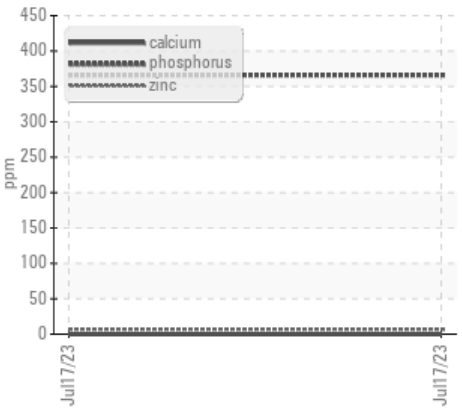
Additives

ADDITIVES		method	limit/base	current	history1	history2
Boron	ppm	ASTM D5185m		**0**	---	---
Barium	ppm	ASTM D5185m		**0**	---	---
Molybdenum	ppm	ASTM D5185m		**0**	---	---
Manganese	ppm	ASTM D5185m		**0**	---	---
Magnesium	ppm	ASTM D5185m		**<1**	---	---
Calcium	ppm	ASTM D5185m		▲ **0**	---	---
Phosphorus	ppm	ASTM D5185m		**366**	---	---
Zinc	ppm	ASTM D5185m		▲ **7**	---	---
Sulfur	ppm	ASTM D5185m		**2292**	---	---

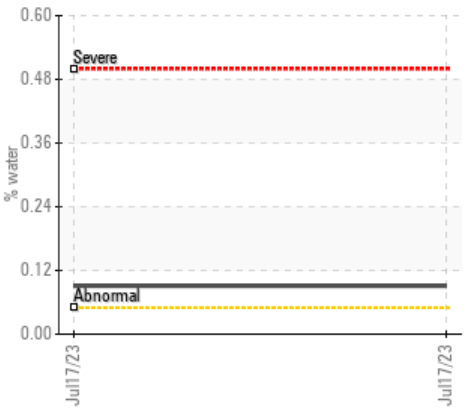
CONTAMINANTS		method	limit/base	current	history1	history2
Silicon	ppm	ASTM D5185m	>15	**6**	---	---
Sodium	ppm	ASTM D5185m		**0**	---	---
Potassium	ppm	ASTM D5185m	>20	**1**	---	---
Water	%	ASTM D6304	>0.05	▲ **0.091**	---	---
ppm Water	ppm	ASTM D6304	>500	▲ **910**	---	---
