OIL ANALYSIS REPORT

Area
METRO
Machine Id
METRO 20011
Component
Transmission (Manual)
Fluid
GEAR OIL SAE 80 (--- GAL)

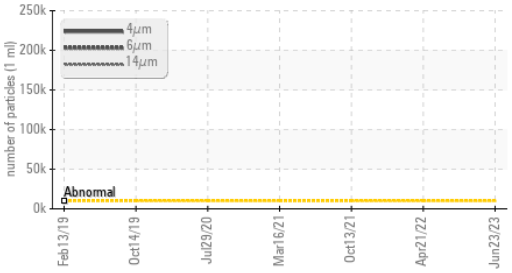
Particle Trend

Contamination
There is a high amount of silt (particulates < 14 microns in size) present in the fluid.

FLUID CLEANLINESS		method	limit/base	current	history1	history2
Particles >4µm		ASTM D7647	>10000	▲ **212343**	---	---
Particles >6µm		ASTM D7647	>2500	▲ **74675**	---	---
Particles >14µm		ASTM D7647	>320	**209**	---	---
Particles >21µm		ASTM D7647	>80	**26**	---	---
Particles >38µm		ASTM D7647	>20	**0**	---	---
Particles >71µm		ASTM D7647	>4	**0**	---	---
Oil Cleanliness		ISO 4406 (c)	>20/18/15	▲ **25/23/15**	---	---

Recommendation
No corrective action is recommended at this time. Resample at the next service interval to monitor.

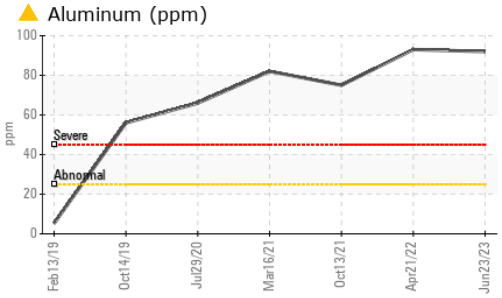
Aluminum (ppm)

Wear
The aluminum level is abnormal. The tin level is abnormal.

WEAR METALS		method	limit/base	current	history1	history2
Iron	ppm	ASTM D5185m	>200	**103**	95	81
Chromium	ppm	ASTM D5185m	>5	**<1**	<1	<1
Nickel	ppm	ASTM D5185m	>5	**<1**	0	0
Titanium	ppm	ASTM D5185m		**0**	0	0
Silver	ppm	ASTM D5185m	>7	**0**	<1	0
Aluminum	ppm	ASTM D5185m	>25	▲ **92**	▲ 93	▲ 75
Lead	ppm	ASTM D5185m	>45	**<1**	<1	0
Copper	ppm	ASTM D5185m	>225	**3**	5	5
Tin	ppm	ASTM D5185m	>10	▲ **18**	▲ 16	▲ 15
Antimony	ppm	ASTM D5185m		**---**	---	0
Vanadium	ppm	ASTM D5185m		**0**	0	0
Cadmium	ppm	ASTM D5185m		**0**	0	0

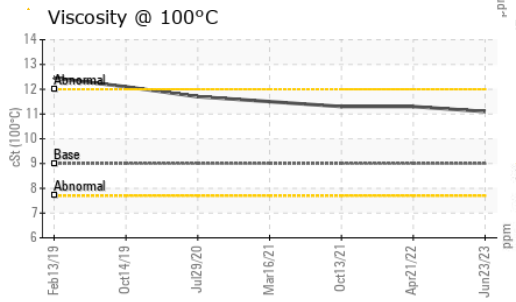
Viscosity @ 100°C

FLUID PROPERTIES		method	limit/base	current	history1	history2
Visc @ 40°C	cSt	ASTM D445	74	**65.9**	66.9	68.0
Visc @ 100°C	cSt	ASTM D445	9.0	**11.1**	11.3	11.3
Viscosity Index (VI)	Scale	ASTM D2270	94	**161**	162	159
